East Sussex County Council

Sandbanks 1 Cacklebury Close, Hailsham,
East Sussex, BN27 3LF

WYG Asbestos Management Survey Report

15 Apr 2020

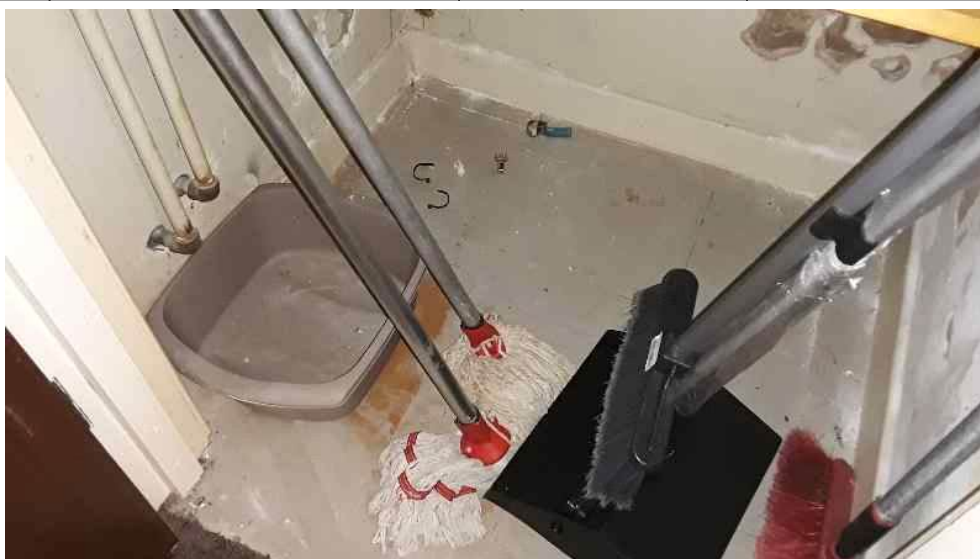
Inspection Number	46	Reference Number:	As Sample EC002589
Inspection / Sample	Visually similar to	Inspection Cross Reference / Visual I.D.	As Sample

Building	Main Building
Floor Level	Ground Floor
Area / Room	0.37 Store
Feature	Grey thermoplastic floor tiles & bitumen adhesive
Product Type	Well Bound Material
Extent Amount	1 m ²

Product Score	Low Fibre Release - Asbestos reinforced composites (plastics, resins, mastics, roofing felts, vinyl floor tiles, semi-rigid paints or decorative finishes, asbestos cement, etc.)	1
Extent of Damage	Good condition - no visible damage	0
Surface Treatment	Reinforced plastics, resins, vinyl tiles, well bound materials, bitumen adhesives, damp proof course	0
Asbestos Type	Chrysotile	1

Recommendation	Manage
----------------	--------

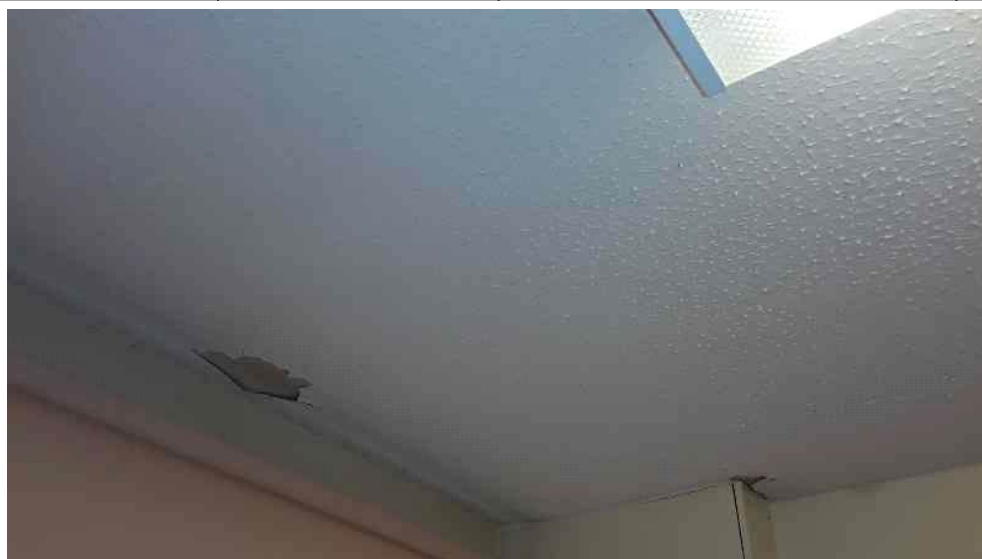
Inspection Number	47	Reference Number:	EC002594
Inspection / Sample	Sample taken	Inspection Cross Reference / Visual I.D.	N.A.D.I.S

Building	Main Building
Floor Level	Ground Floor
Area / Room	0.38 Kitchen
Feature	Textured coating to plasterboard ceiling
Product Type	Textured Coating
Extent Amount	8 m ²

Product Score	Low Fibre Release - Asbestos reinforced composites (plastics, resins, mastics, roofing felts, vinyl floor tiles, semi-rigid paints or decorative finishes, asbestos cement, etc.)	0
Extent of Damage	Medium damage - significant breakage of materials or several small areas where material has been damaged revealing loose asbestos fibres	0
Surface Treatment	Enclosed sprays and lagging, Sealed AIB, asbestos cement, textured coating, gasket	0
Asbestos Type	No Asbestos Detected	0

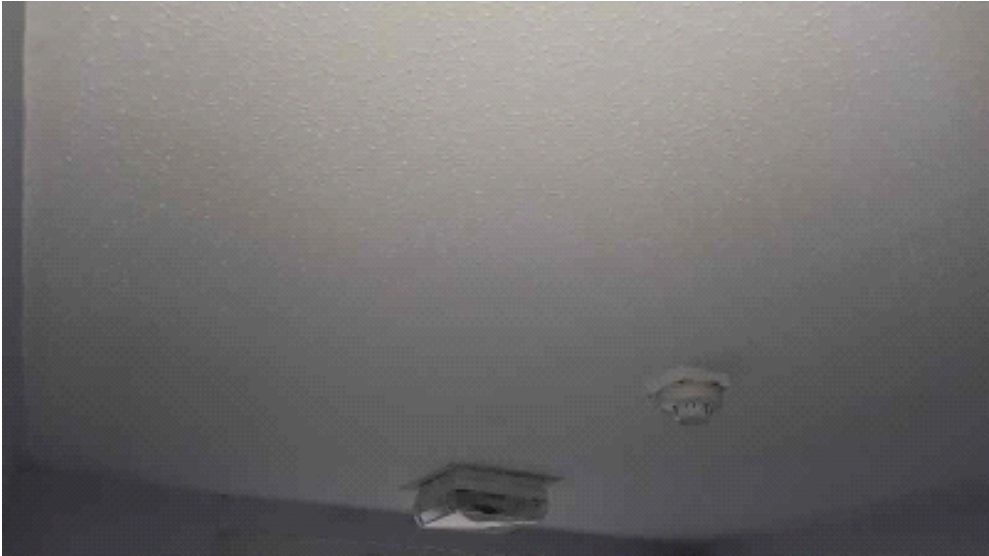
Inspection Number	48	Reference Number:	As Sample EC002593
Inspection / Sample	Visually similar to	Inspection Cross Reference / Visual I.D.	As Sample

Building	Main Building
Floor Level	Ground Floor
Area / Room	0.39 Bedroom 3
Feature	Textured coating to plasterboard ceiling
Product Type	Textured Coating
Extent Amount	12 m ²

Product Score	Low Fibre Release - Asbestos reinforced composites (plastics, resins, mastics, roofing felts, vinyl floor tiles, semi-rigid paints or decorative finishes, asbestos cement, etc.)	1
Extent of Damage	Good condition - no visible damage	0
Surface Treatment	Enclosed sprays and lagging, Sealed AIB, asbestos cement, textured coating, gasket	1
Asbestos Type	Chrysotile	1

Recommendation	Manage
----------------	--------

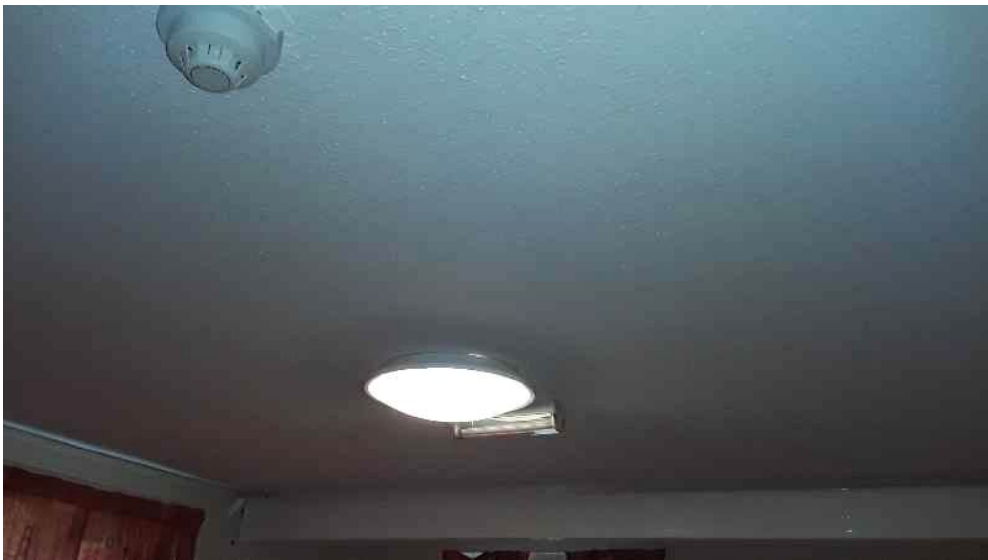
Inspection Number	49	Reference Number:	As Sample EC002593
Inspection / Sample	Visually similar to	Inspection Cross Reference / Visual I.D.	As Sample

Building	Main Building
Floor Level	Ground Floor
Area / Room	0.40 Bedroom 2
Feature	Textured coating to plasterboard ceiling
Product Type	Textured Coating
Extent Amount	15 m ²

Product Score	Low Fibre Release - Asbestos reinforced composites (plastics, resins, mastics, roofing felts, vinyl floor tiles, semi-rigid paints or decorative finishes, asbestos cement, etc.)	1
Extent of Damage	Good condition - no visible damage	0
Surface Treatment	Enclosed sprays and lagging, Sealed AIB, asbestos cement, textured coating, gasket	1
Asbestos Type	Chrysotile	1

Recommendation	Manage
----------------	--------

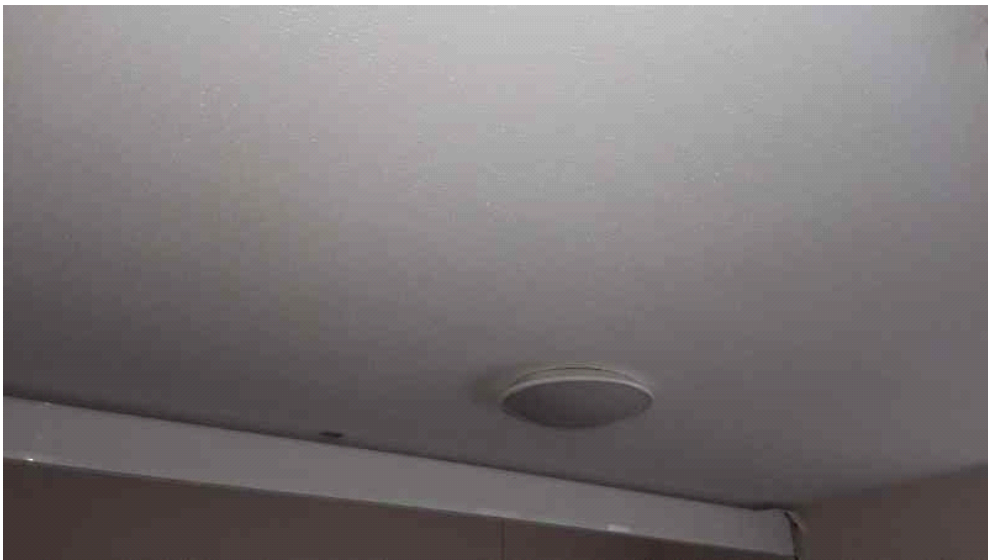
Inspection Number	50	Reference Number:	As Sample EC002593
Inspection / Sample	Visually similar to	Inspection Cross Reference / Visual I.D.	As Sample

Building	Main Building
Floor Level	Ground Floor
Area / Room	0.41 Bedroom 1
Feature	Textured coating to plasterboard ceiling
Product Type	Textured Coating
Extent Amount	12 m ²

Product Score	Low Fibre Release - Asbestos reinforced composites (plastics, resins, mastics, roofing felts, vinyl floor tiles, semi-rigid paints or decorative finishes, asbestos cement, etc.)	1
Extent of Damage	Good condition - no visible damage	0
Surface Treatment	Enclosed sprays and lagging, Sealed AIB, asbestos cement, textured coating, gasket	1
Asbestos Type	Chrysotile	1

Recommendation	Manage
----------------	--------

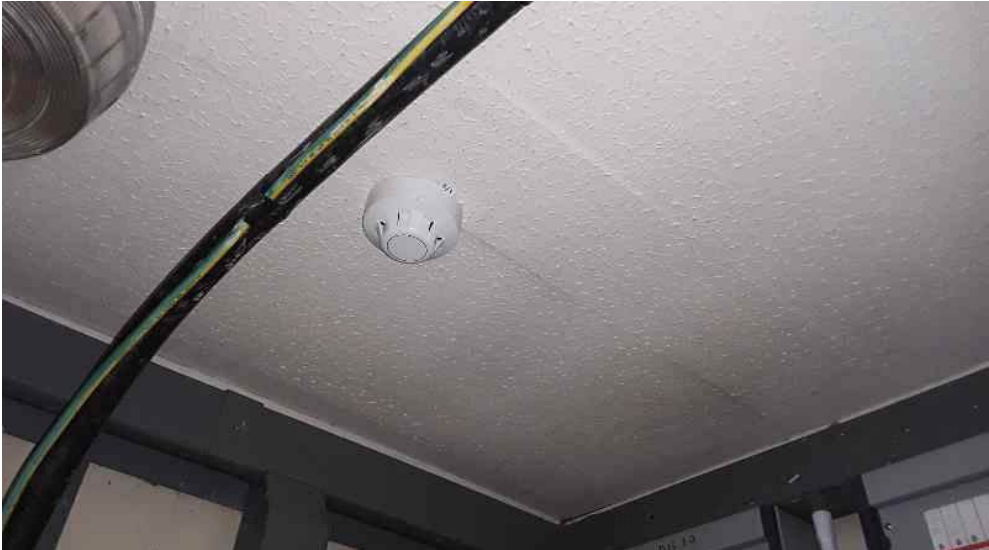
Inspection Number	51	Reference Number:	As Sample EC002593
Inspection / Sample	Visually similar to	Inspection Cross Reference / Visual I.D.	As Sample

Building	Main Building
Floor Level	Ground Floor
Area / Room	0.42 Electrical Cupboard
Feature	Textured coating to plasterboard ceiling
Product Type	Textured Coating
Extent Amount	1 m ²

Product Score	Low Fibre Release - Asbestos reinforced composites (plastics, resins, mastics, roofing felts, vinyl floor tiles, semi-rigid paints or decorative finishes, asbestos cement, etc.)	1
Extent of Damage	Low damage - a few scratches or surface marks; broken edges on boards, tiles etc.	1
Surface Treatment	Enclosed sprays and lagging, Sealed AIB, asbestos cement, textured coating, gasket	1
Asbestos Type	Chrysotile	1

Recommendation	Manage
----------------	--------

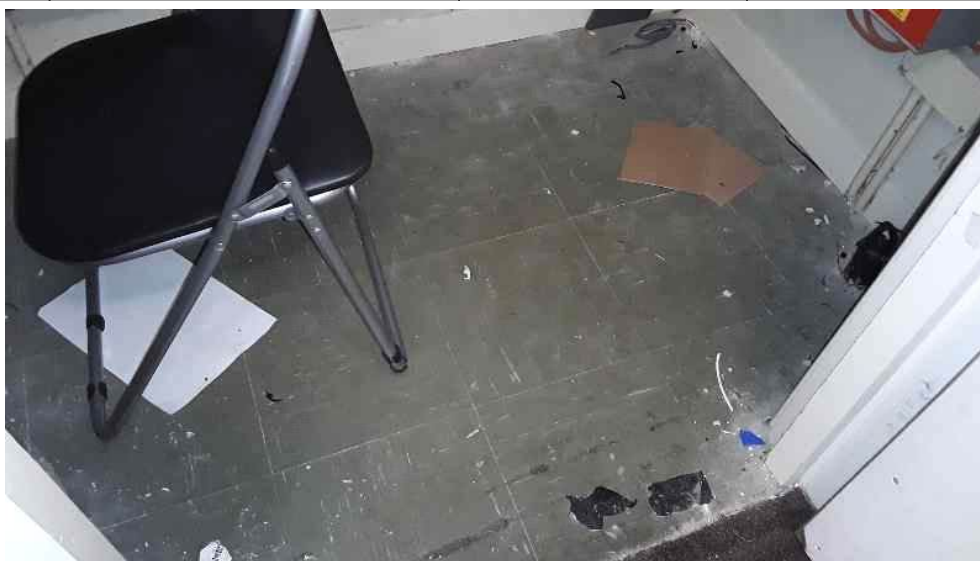
Inspection Number	52	Reference Number:	As Sample EC002589
Inspection / Sample	Visually similar to	Inspection Cross Reference / Visual I.D.	As Sample

Building	Main Building
Floor Level	Ground Floor
Area / Room	0.42 Electrical Cupboard
Feature	Grey thermoplastic floor tiles & bitumen adhesive
Product Type	Well Bound Material
Extent Amount	1 m ²

Product Score	Low Fibre Release - Asbestos reinforced composites (plastics, resins, mastics, roofing felts, vinyl floor tiles, semi-rigid paints or decorative finishes, asbestos cement, etc.)	1
Extent of Damage	Good condition - no visible damage	0
Surface Treatment	Reinforced plastics, resins, vinyl tiles, well bound materials, bitumen adhesives, damp proof course	0
Asbestos Type	Chrysotile	1

Recommendation	Manage
----------------	--------

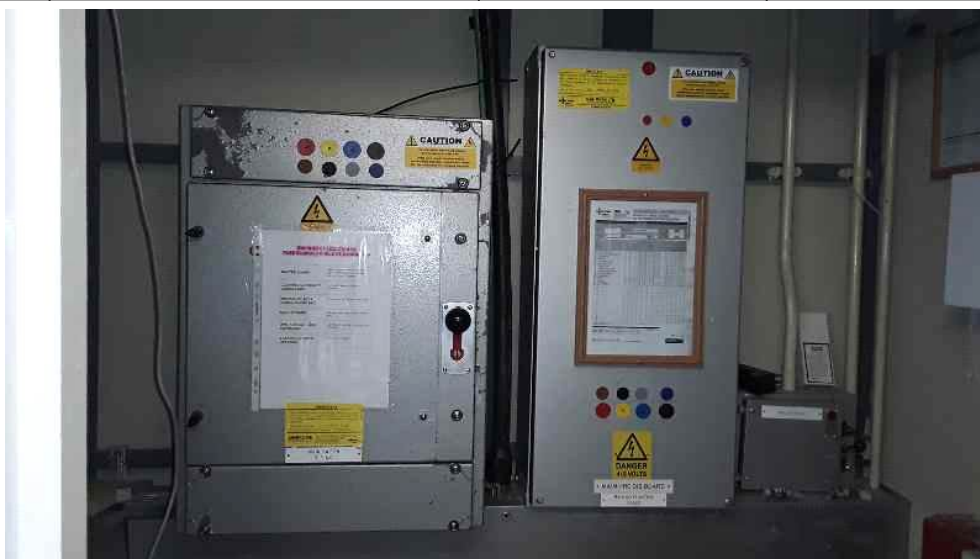
Inspection Number	53	Reference Number:	N/A
Inspection / Sample	Visual Inspection	Inspection Cross Reference / Visual I.D.	Asbestos Presumed

Building	Main Building
Floor Level	Ground Floor
Area / Room	0.42 Electrical Cupboard
Feature	Presumed textiles within live electrics
Product Type	Asbestos Textiles
Extent Amount	6 no.

Product Score	Low Fibre Release - Asbestos reinforced composites (plastics, resins, mastics, roofing felts, vinyl floor tiles, semi-rigid paints or decorative finishes, asbestos cement, etc.)	1
Extent of Damage	Good condition - no visible damage	0
Surface Treatment	Unsealed AIB, encapsulated lagging and sprays, ropes, textiles, paper	2
Asbestos Type	Chrysotile	1

Recommendation	Manage
----------------	--------

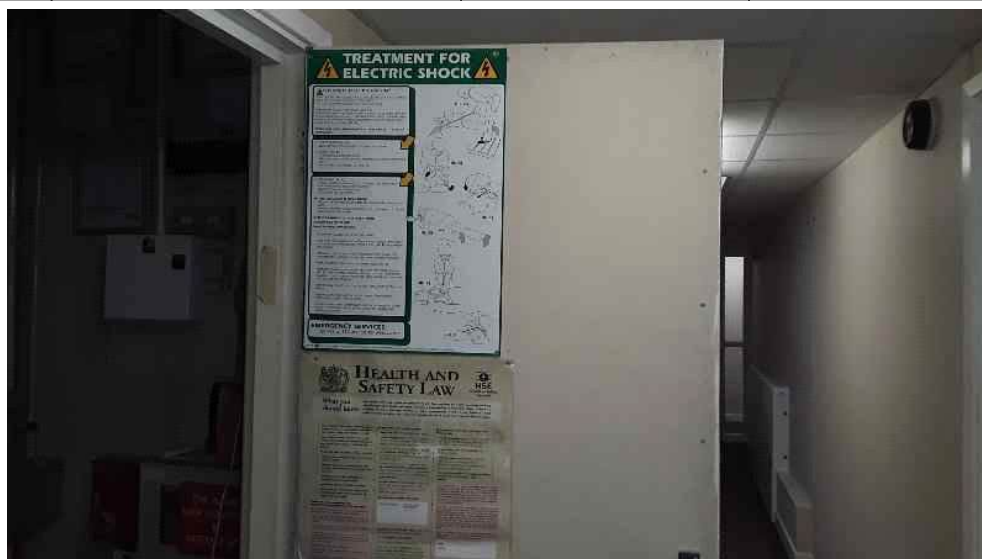
Inspection Number	55	Reference Number:	As Sample EC002537
Inspection / Sample	Visually similar to	Inspection Cross Reference / Visual I.D.	As Sample

Building	Main Building
Floor Level	Ground Floor
Area / Room	0.42 Electrical Cupboard
Feature	Insulating board panel to rear of door
Product Type	Insulating Board
Extent Amount	2 m ²

Product Score	Medium Fibre Release - Asbestos insulating board, mill board, other low density insulation board, asbestos textiles, gaskets, rope and woven textiles, asbestos paper and felt	0
Extent of Damage	Low damage - a few scratches or surface marks; broken edges on boards, tiles etc.	0
Surface Treatment	Enclosed sprays and lagging, Sealed AIB, asbestos cement, textured coating, gasket	0
Asbestos Type	No Asbestos Detected	0

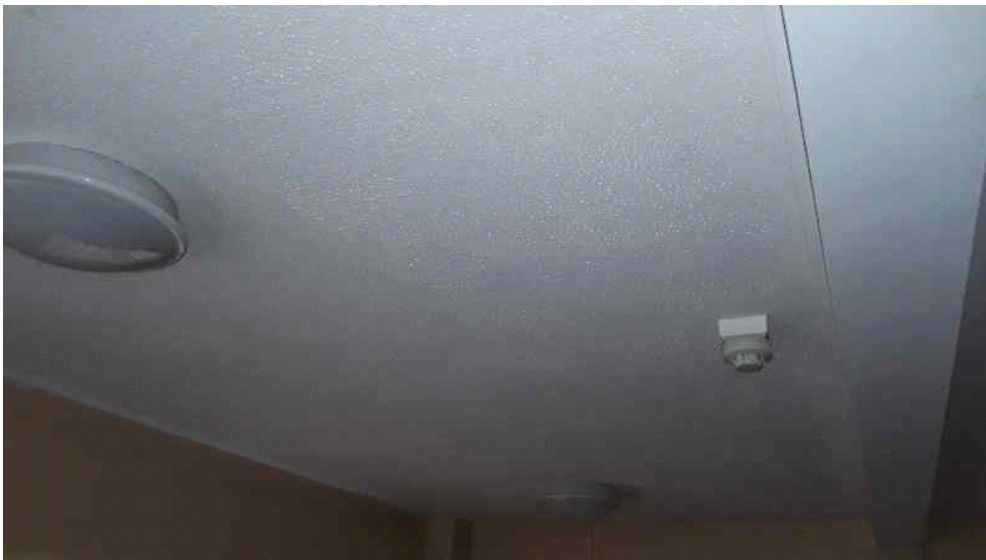
Inspection Number	57	Reference Number:	As Sample EC002593
Inspection / Sample	Visually similar to	Inspection Cross Reference / Visual I.D.	As Sample

Building	Main Building
Floor Level	Ground Floor
Area / Room	0.46 Day Room
Feature	Textured coating to plasterboard ceiling
Product Type	Textured Coating
Extent Amount	20 m ²

Product Score	Low Fibre Release - Asbestos reinforced composites (plastics, resins, mastics, roofing felts, vinyl floor tiles, semi-rigid paints or decorative finishes, asbestos cement, etc.)	1
Extent of Damage	Good condition - no visible damage	0
Surface Treatment	Enclosed sprays and lagging, Sealed AIB, asbestos cement, textured coating, gasket	1
Asbestos Type	Chrysotile	1

Recommendation	Manage
----------------	--------

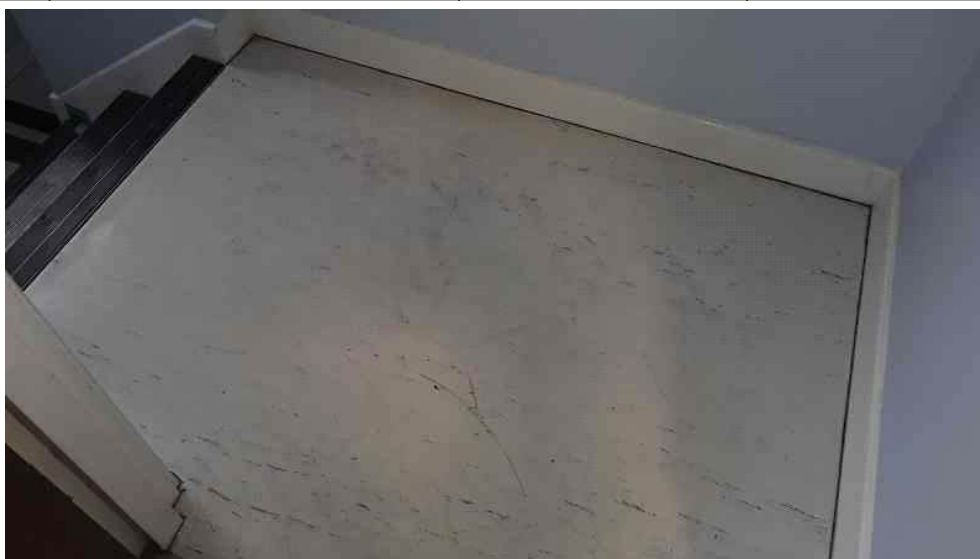
Inspection Number	59	Reference Number:	As Sample EC002592
Inspection / Sample	Visually similar to	Inspection Cross Reference / Visual I.D.	As Sample

Building	Main Building
Floor Level	1st Floor
Area / Room	1.01 Landing
Feature	Cream laminate flooring
Product Type	Reinforced Composite
Extent Amount	2 m ²

Product Score	Low Fibre Release - Asbestos reinforced composites (plastics, resins, mastics, roofing felts, vinyl floor tiles, semi-rigid paints or decorative finishes, asbestos cement, etc.)	0
Extent of Damage	Low damage - a few scratches or surface marks; broken edges on boards, tiles etc.	0
Surface Treatment	Reinforced plastics, resins, vinyl tiles, well bound materials, bitumen adhesives, damp proof course	0
Asbestos Type	No Asbestos Detected	0

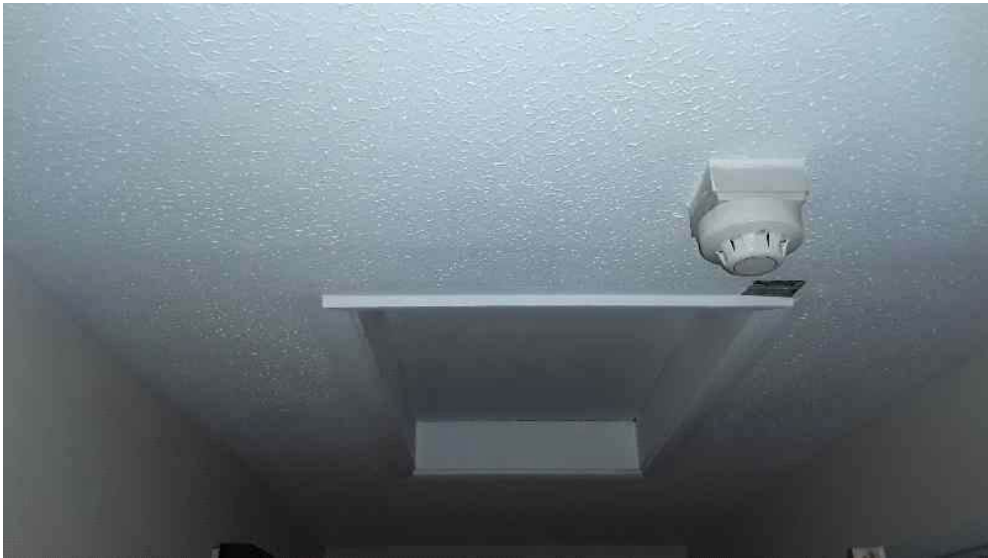
Inspection Number	60	Reference Number:	As Sample EC002596
Inspection / Sample	Visually similar to	Inspection Cross Reference / Visual I.D.	As Sample

Building	Main Building
Floor Level	1st Floor
Area / Room	1.C01 Circulation
Feature	Textured coating to plasterboard ceiling
Product Type	Textured Coating
Extent Amount	6 m ²

Product Score	Low Fibre Release - Asbestos reinforced composites (plastics, resins, mastics, roofing felts, vinyl floor tiles, semi-rigid paints or decorative finishes, asbestos cement, etc.)	1
Extent of Damage	Good condition - no visible damage	0
Surface Treatment	Enclosed sprays and lagging, Sealed AIB, asbestos cement, textured coating, gasket	1
Asbestos Type	Chrysotile	1

Recommendation	Manage
----------------	--------

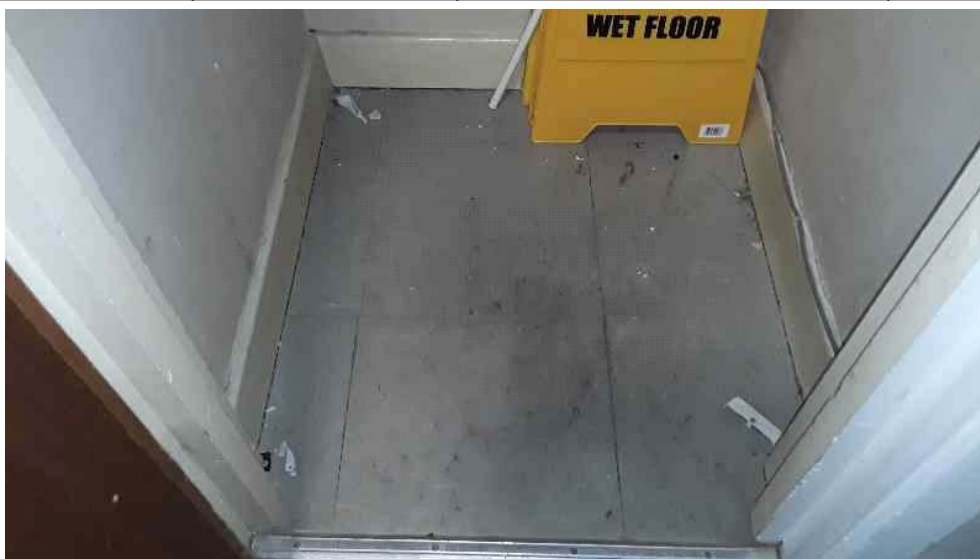
Inspection Number	62	Reference Number:	EC002597
Inspection / Sample	Sample taken	Inspection Cross Reference / Visual I.D.	Asbestos Identified

Building	Main Building
Floor Level	1st Floor
Area / Room	1.02 Store 1
Feature	Grey thermoplastic floor tiles & bitumen adhesive
Product Type	Well Bound Material
Extent Amount	1 m2

Product Score	Low Fibre Release - Asbestos reinforced composites (plastics, resins, mastics, roofing felts, vinyl floor tiles, semi-rigid paints or decorative finishes, asbestos cement, etc.)	1
Extent of Damage	Good condition - no visible damage	0
Surface Treatment	Reinforced plastics, resins, vinyl tiles, well bound materials, bitumen adhesives, damp proof course	0
Asbestos Type	Chrysotile	1

Recommendation	Manage
----------------	--------

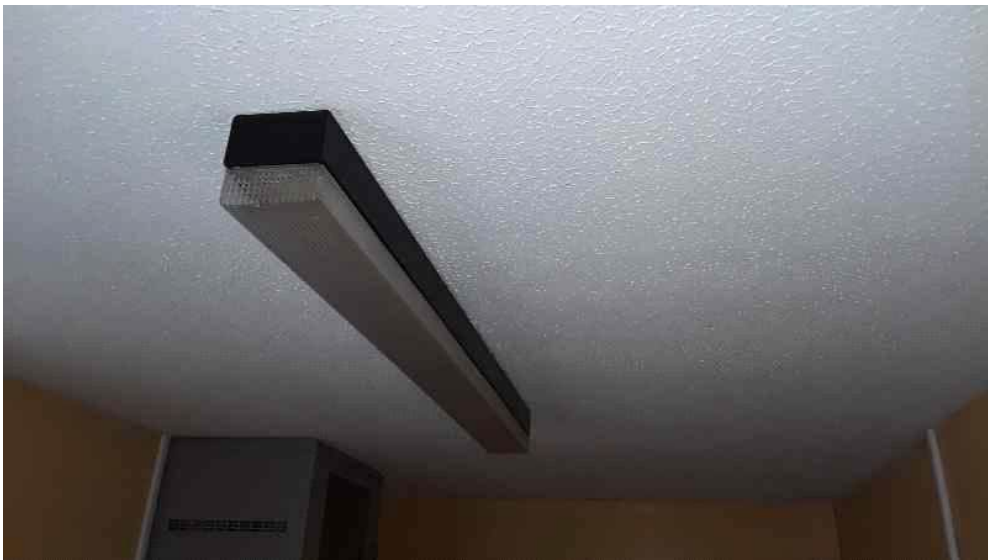
Inspection Number	63	Reference Number:	As Sample EC002596
Inspection / Sample	Visually similar to	Inspection Cross Reference / Visual I.D.	As Sample

Building	Main Building
Floor Level	1st Floor
Area / Room	1.03 Office
Feature	Textured coating to plasterboard ceiling
Product Type	Textured Coating
Extent Amount	8 m ²

Product Score	Low Fibre Release - Asbestos reinforced composites (plastics, resins, mastics, roofing felts, vinyl floor tiles, semi-rigid paints or decorative finishes, asbestos cement, etc.)	1
Extent of Damage	Good condition - no visible damage	0
Surface Treatment	Enclosed sprays and lagging, Sealed AIB, asbestos cement, textured coating, gasket	1
Asbestos Type	Chrysotile	1

Recommendation	Manage
----------------	--------

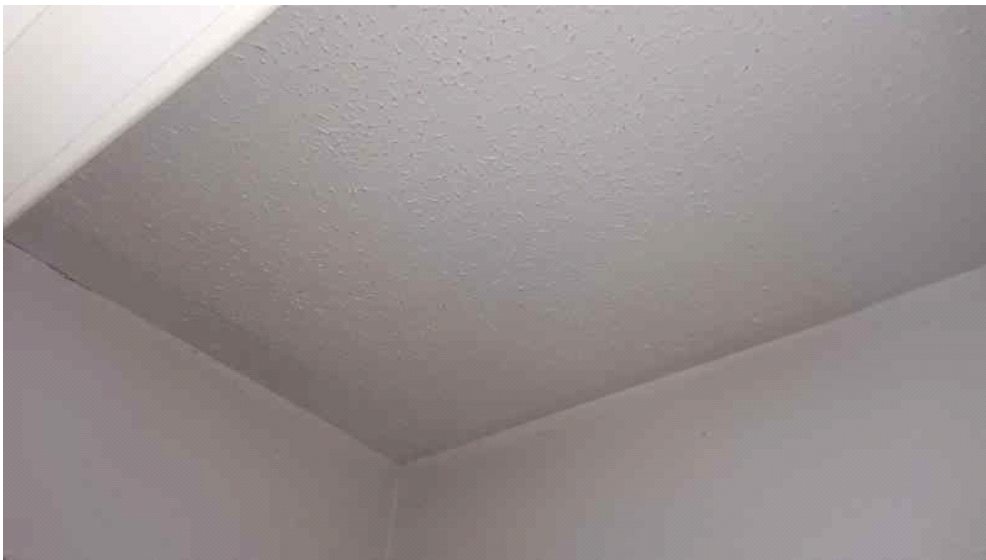
Inspection Number	64	Reference Number:	As Sample EC002596
Inspection / Sample	Visually similar to	Inspection Cross Reference / Visual I.D.	As Sample

Building	Main Building
Floor Level	1st Floor
Area / Room	1.04 Store 2
Feature	Textured coating to plasterboard ceiling
Product Type	Textured Coating
Extent Amount	1 m ²

Recommendation	Manage
----------------	--------

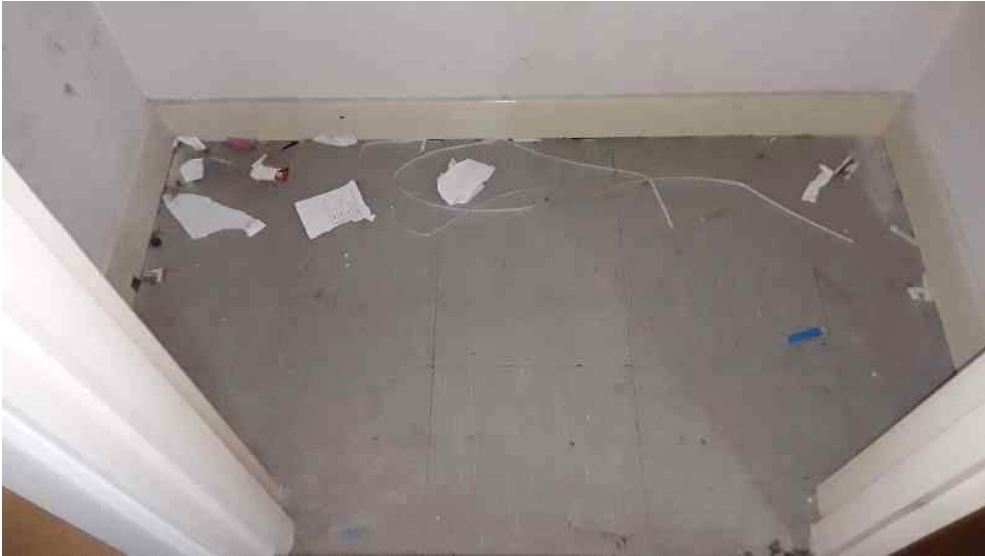
Inspection Number	65	Reference Number:	As Sample EC002597
Inspection / Sample	Visually similar to	Inspection Cross Reference / Visual I.D.	As Sample

Building	Main Building
Floor Level	1st Floor
Area / Room	1.04 Store 2
Feature	Grey thermoplastic floor tiles & bitumen adhesive
Product Type	Well Bound Material
Extent Amount	1 m ²

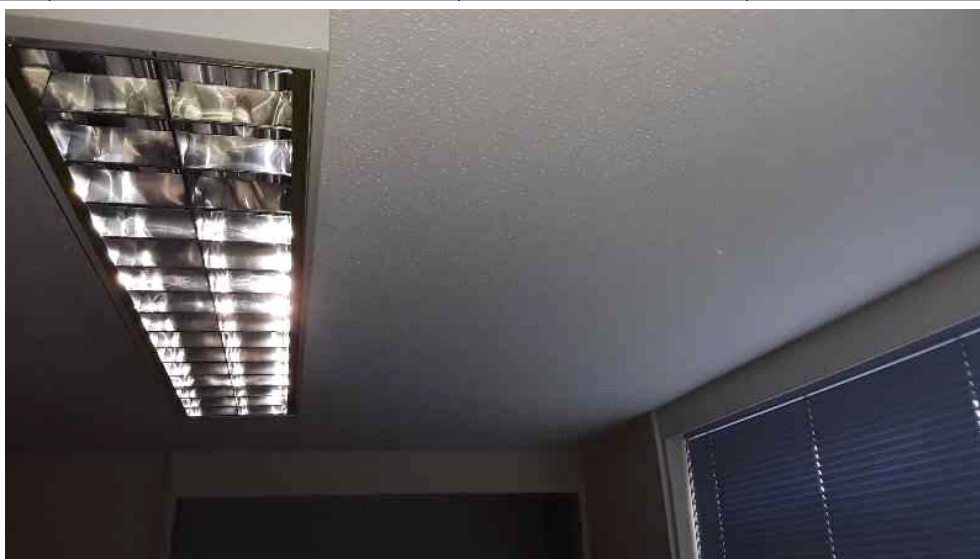
Inspection Number	67	Reference Number:	As Sample EC002598
Inspection / Sample	Visually similar to	Inspection Cross Reference / Visual I.D.	As Sample

Building	Main Building
Floor Level	1st Floor
Area / Room	1.07 Office
Feature	Textured coating to plasterboard ceiling
Product Type	Textured Coating
Extent Amount	12 m ²

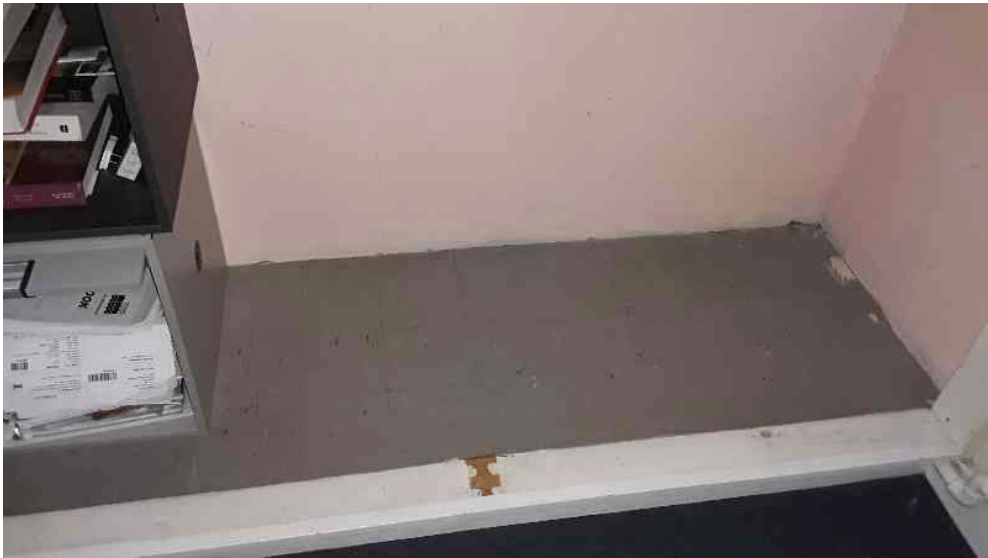
Inspection Number	68	Reference Number:	As Sample EC002597
Inspection / Sample	Visually similar to	Inspection Cross Reference / Visual I.D.	As Sample

Building	Main Building
Floor Level	1st Floor
Area / Room	1.07 Office
Feature	Grey thermoplastic floor tiles & bitumen adhesive to cupboard
Product Type	Well Bound Material
Extent Amount	2 m ²

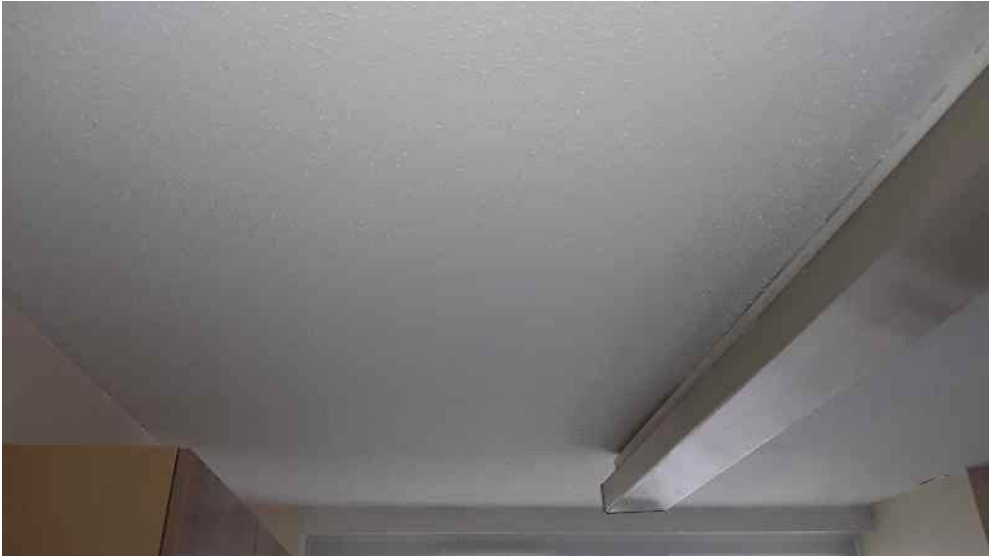
Inspection Number	69	Reference Number:	As Sample EC002598
Inspection / Sample	Visually similar to	Inspection Cross Reference / Visual I.D.	As Sample

Building	Main Building
Floor Level	1st Floor
Area / Room	1.08 Kitchen
Feature	Textured coating to plasterboard ceiling
Product Type	Textured Coating
Extent Amount	8 m ²

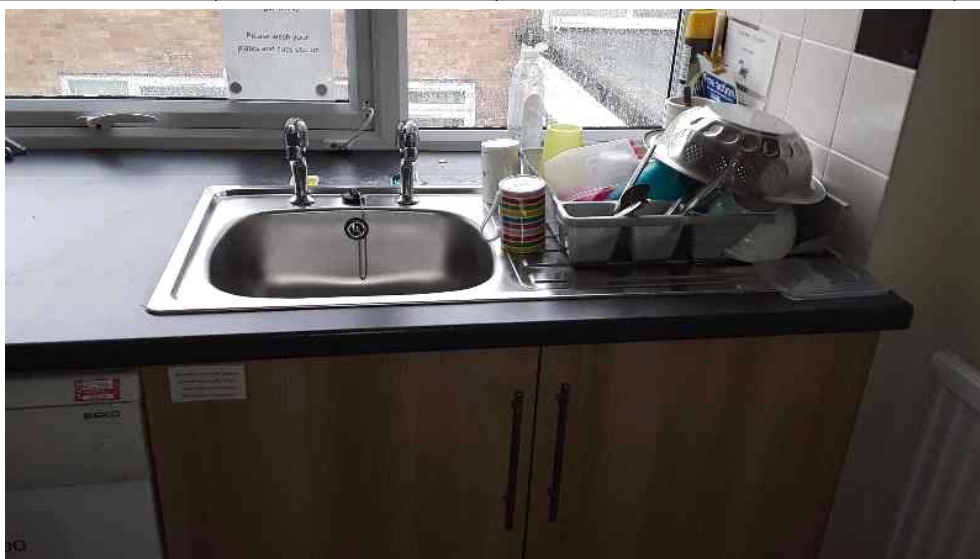
Inspection Number	70	Reference Number:	EC002599
Inspection / Sample	Sample taken	Inspection Cross Reference / Visual I.D.	N.A.D.I.S

Building	Main Building
Floor Level	1st Floor
Area / Room	1.08 Kitchen
Feature	Acoustic pads to sink unit
Product Type	Well Bound Material
Extent Amount	2 no.

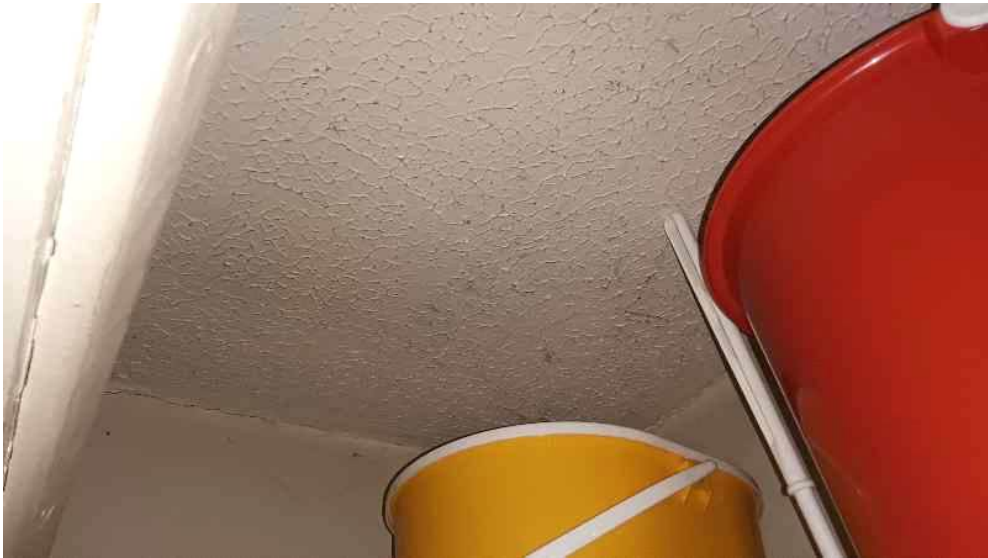
Inspection Number	71	Reference Number:	As Sample EC002596
Inspection / Sample	Visually similar to	Inspection Cross Reference / Visual I.D.	As Sample

Building	Main Building
Floor Level	1st Floor
Area / Room	1.09 Store 3
Feature	Textured coating to plasterboard ceiling
Product Type	Textured Coating
Extent Amount	1 m ²

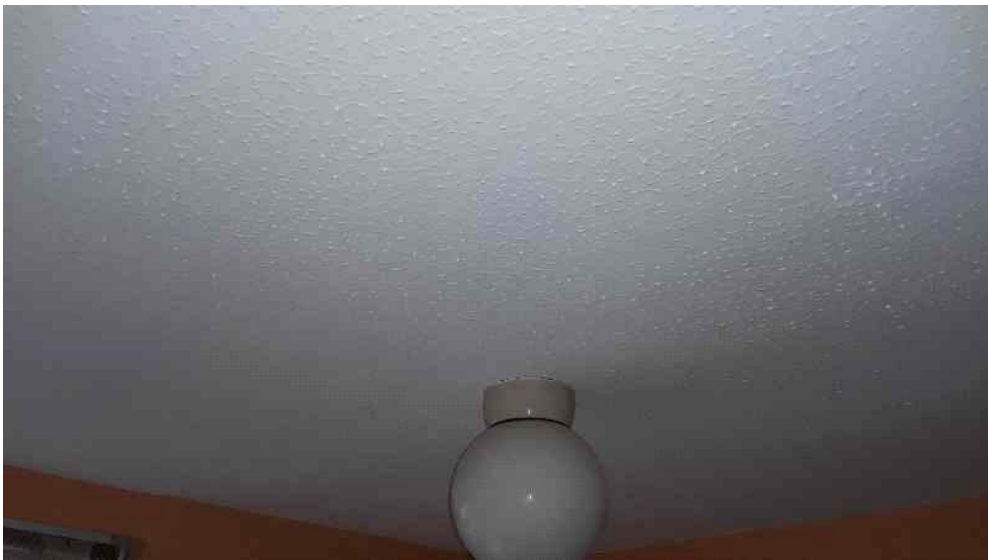
Inspection Number	73	Reference Number:	As Sample EC002598
Inspection / Sample	Visually similar to	Inspection Cross Reference / Visual I.D.	As Sample

Building	Main Building
Floor Level	1st Floor
Area / Room	1.10 Bathroom
Feature	Textured coating to plasterboard ceiling
Product Type	Textured Coating
Extent Amount	4 m ²

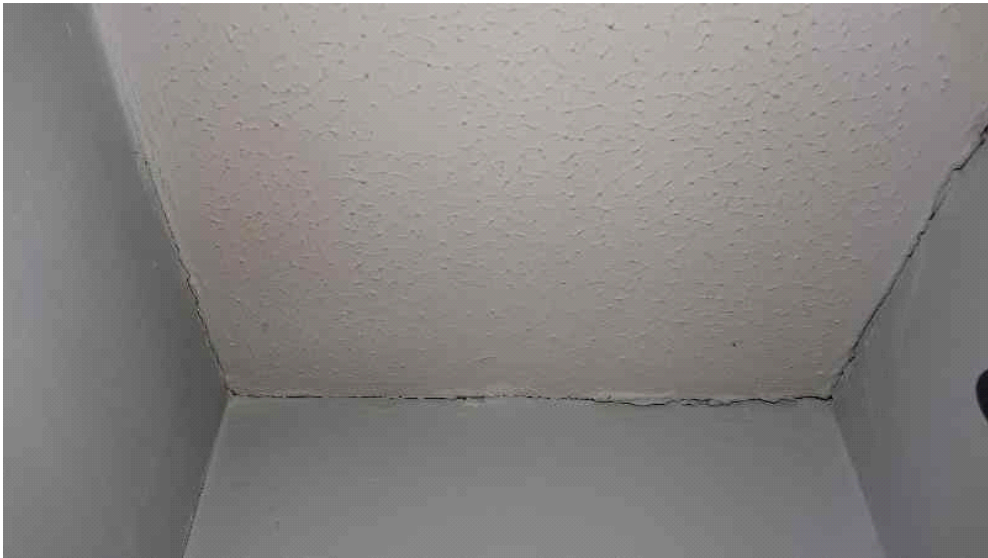
Inspection Number	74	Reference Number:	As Sample EC002596
Inspection / Sample	Visually similar to	Inspection Cross Reference / Visual I.D.	As Sample

Building	Main Building
Floor Level	1st Floor
Area / Room	1.11 Store 4
Feature	Textured coating to plasterboard ceiling
Product Type	Textured Coating
Extent Amount	1 m ²

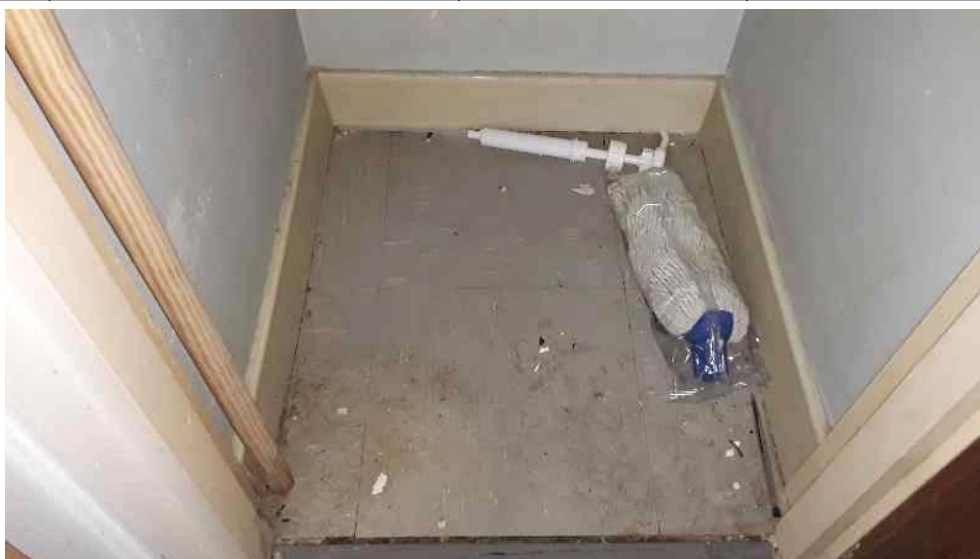
Inspection Number	75	Reference Number:	As Sample EC002597
Inspection / Sample	Visually similar to	Inspection Cross Reference / Visual I.D.	As Sample

Building	Main Building
Floor Level	1st Floor
Area / Room	1.11 Store 4
Feature	Grey thermoplastic floor tiles & bitumen adhesive
Product Type	Well Bound Material
Extent Amount	1 m ²

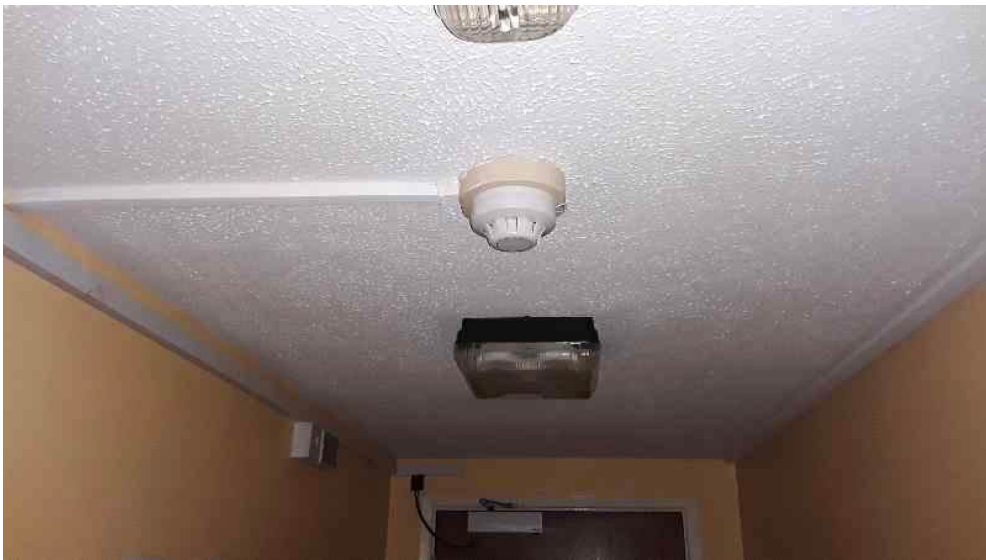
Inspection Number	77	Reference Number:	As Sample EC002600
Inspection / Sample	Visually similar to	Inspection Cross Reference / Visual I.D.	As Sample

Building	Main Building
Floor Level	1st Floor
Area / Room	1.C02 Circulation
Feature	Textured coating to plasterboard ceiling
Product Type	Textured Coating
Extent Amount	4 m ²

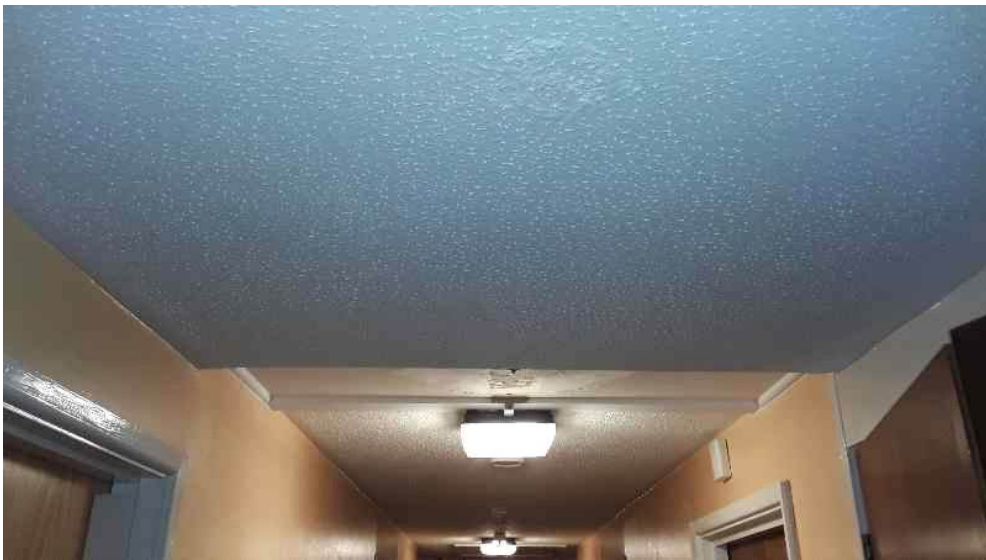
Inspection Number	79	Reference Number:	As Sample EC002600
Inspection / Sample	Visually similar to	Inspection Cross Reference / Visual I.D.	As Sample

Building	Main Building
Floor Level	1st Floor
Area / Room	1.C04 Circulation
Feature	Textured coating to plasterboard ceiling
Product Type	Textured Coating
Extent Amount	8 m ²

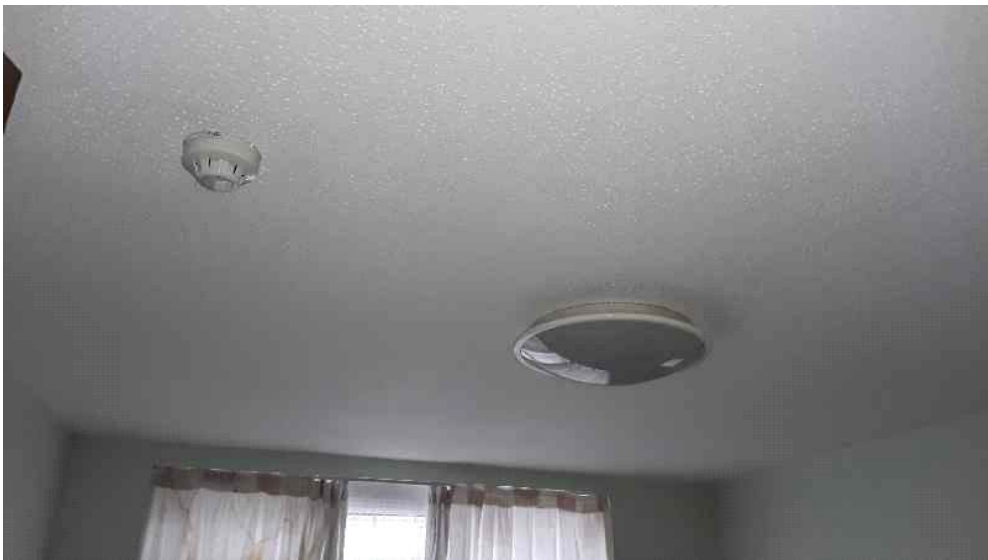
Inspection Number	81	Reference Number:	As Sample EC002601
Inspection / Sample	Visually similar to	Inspection Cross Reference / Visual I.D.	As Sample

Building	Main Building
Floor Level	1st Floor
Area / Room	1.14 Bedroom 14
Feature	Textured coating to plasterboard ceiling
Product Type	Textured Coating
Extent Amount	9 m2

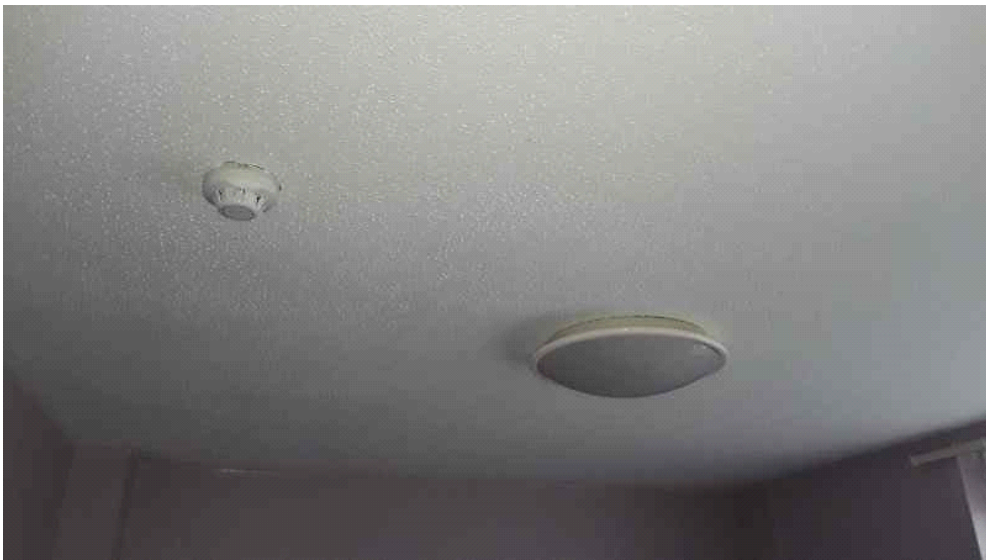
Inspection Number	82	Reference Number:	As Sample EC002601
Inspection / Sample	Visually similar to	Inspection Cross Reference / Visual I.D.	As Sample

Building	Main Building
Floor Level	1st Floor
Area / Room	1.15 Bedroom 15
Feature	Textured coating to plasterboard ceiling
Product Type	Textured Coating
Extent Amount	9 m2

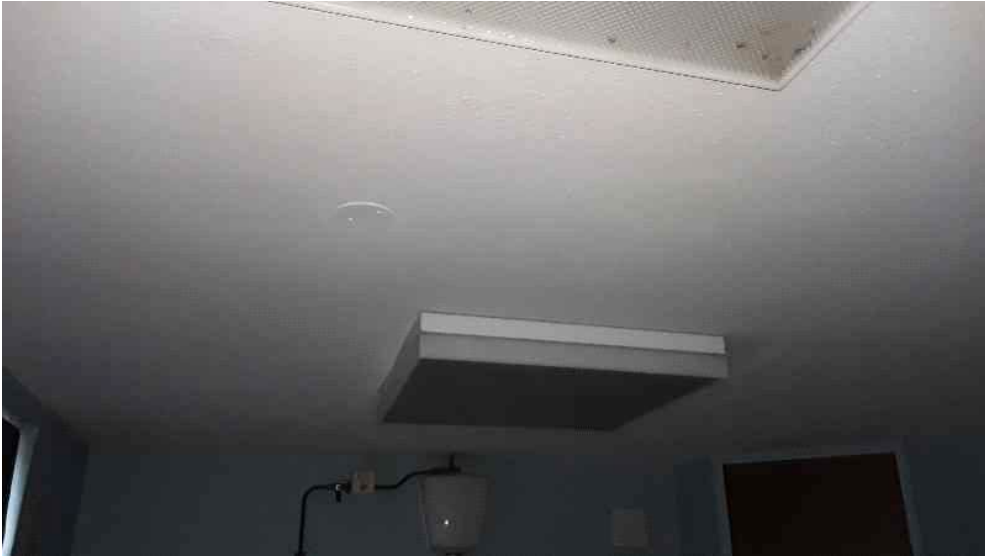
Inspection Number	83	Reference Number:	As Sample EC002601
Inspection / Sample	Visually similar to	Inspection Cross Reference / Visual I.D.	As Sample

Building	Main Building
Floor Level	1st Floor
Area / Room	1.16 Bathroom
Feature	Textured coating to plasterboard ceiling
Product Type	Textured Coating
Extent Amount	12 m ²

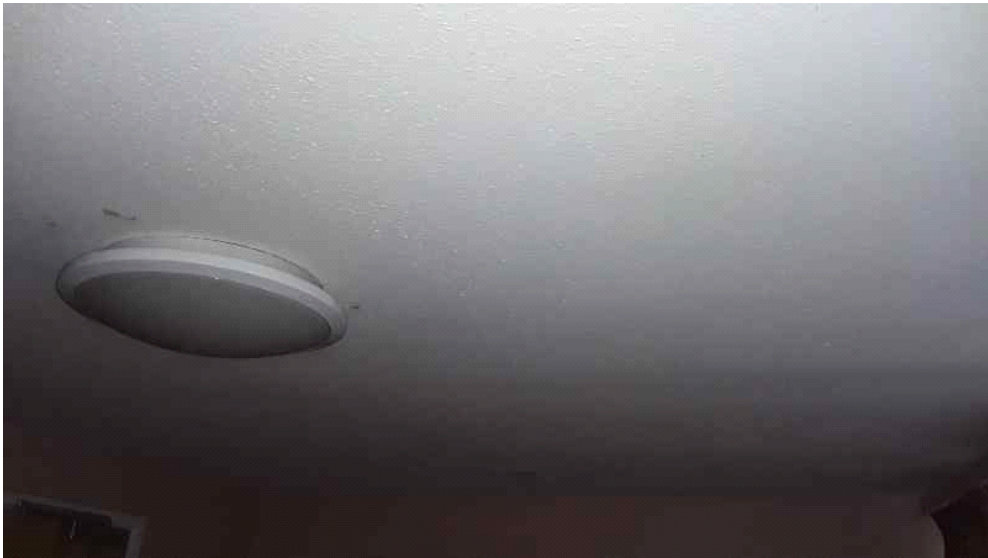
Inspection Number	84	Reference Number:	As Sample EC002601
Inspection / Sample	Visually similar to	Inspection Cross Reference / Visual I.D.	As Sample

Building	Main Building
Floor Level	1st Floor
Area / Room	1.17 Guest Bedroom
Feature	Textured coating to plasterboard ceiling
Product Type	Textured Coating
Extent Amount	17 m ²

Product Score	Low Fibre Release - Asbestos reinforced composites (plastics, resins, mastics, roofing felts, vinyl floor tiles, semi-rigid paints or decorative finishes, asbestos cement, etc.)	1
Extent of Damage	Good condition - no visible damage	0
Surface Treatment	Enclosed sprays and lagging, Sealed AIB, asbestos cement, textured coating, gasket	1
Asbestos Type	Chrysotile	1

Recommendation	Manage
----------------	--------

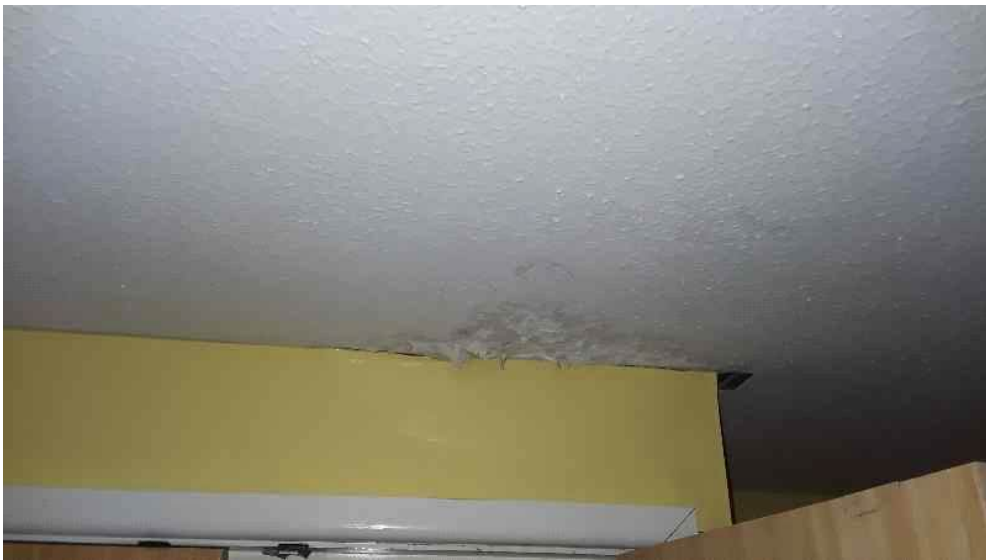
Inspection Number	85	Reference Number:	EC002602
Inspection / Sample	Sample taken	Inspection Cross Reference / Visual I.D.	N.A.D.I.S

Building	Main Building
Floor Level	1st Floor
Area / Room	1.18 Bedroom 16
Feature	Textured coating repair patch to plasterboard ceiling
Product Type	Textured Coating
Extent Amount	1 m2

Product Score	Low Fibre Release - Asbestos reinforced composites (plastics, resins, mastics, roofing felts, vinyl floor tiles, semi-rigid paints or decorative finishes, asbestos cement, etc.)	0
Extent of Damage	Medium damage - significant breakage of materials or several small areas where material has been damaged revealing loose asbestos fibres	0
Surface Treatment	Enclosed sprays and lagging, Sealed AIB, asbestos cement, textured coating, gasket	0
Asbestos Type	No Asbestos Detected	0

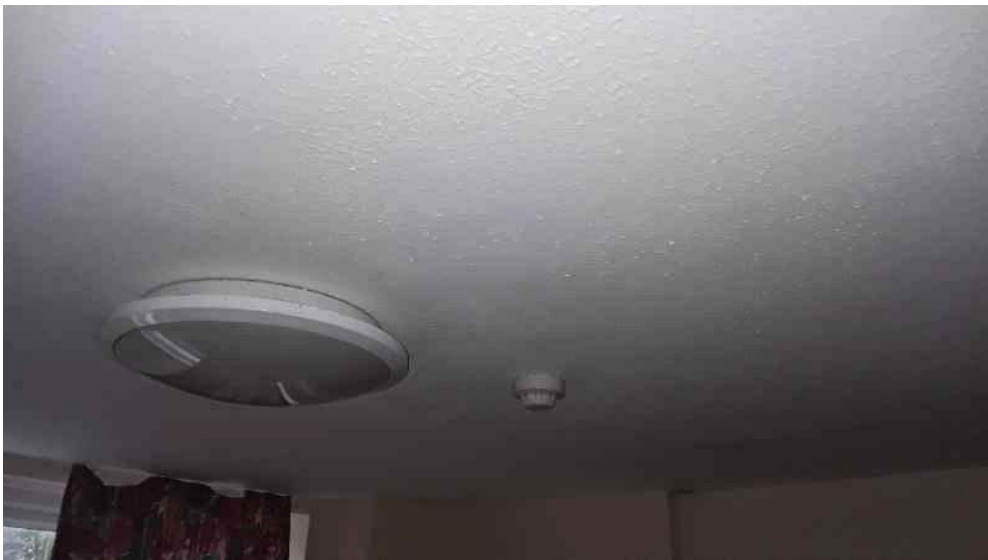
Inspection Number	86	Reference Number:	As Sample EC002601
Inspection / Sample	Visually similar to	Inspection Cross Reference / Visual I.D.	As Sample

Building	Main Building
Floor Level	1st Floor
Area / Room	1.19 Bedroom 17
Feature	Textured coating to plasterboard ceiling
Product Type	Textured Coating
Extent Amount	12 m ²

Product Score	Low Fibre Release - Asbestos reinforced composites (plastics, resins, mastics, roofing felts, vinyl floor tiles, semi-rigid paints or decorative finishes, asbestos cement, etc.)	1
Extent of Damage	Good condition - no visible damage	0
Surface Treatment	Enclosed sprays and lagging, Sealed AIB, asbestos cement, textured coating, gasket	1
Asbestos Type	Chrysotile	1

Recommendation	Manage
----------------	--------
