East Sussex County Council

Sandbanks 1 Cacklebury Close, Hailsham,
East Sussex, BN27 3LF

WYG Asbestos Management Survey Report

15 Apr 2020

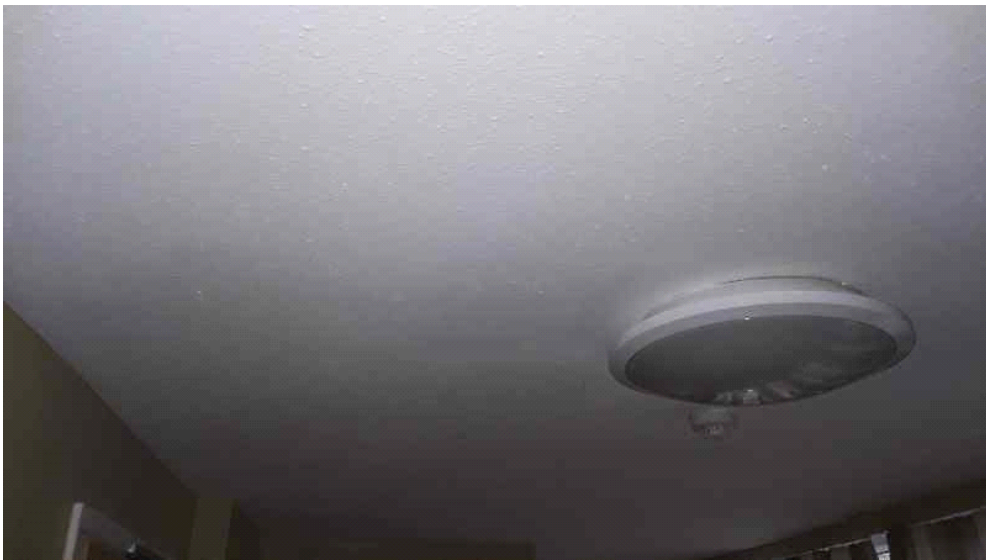
Inspection Number	87	Reference Number:	As Sample EC002601
Inspection / Sample	Visually similar to	Inspection Cross Reference / Visual I.D.	As Sample

Building	Main Building
Floor Level	1st Floor
Area / Room	1.20 Bedroom 18
Feature	Textured coating to plasterboard ceiling
Product Type	Textured Coating
Extent Amount	12 m ²

Product Score	Low Fibre Release - Asbestos reinforced composites (plastics, resins, mastics, roofing felts, vinyl floor tiles, semi-rigid paints or decorative finishes, asbestos cement, etc.)	1
Extent of Damage	Good condition - no visible damage	0
Surface Treatment	Enclosed sprays and lagging, Sealed AIB, asbestos cement, textured coating, gasket	1
Asbestos Type	Chrysotile	1

Recommendation	Manage
----------------	--------

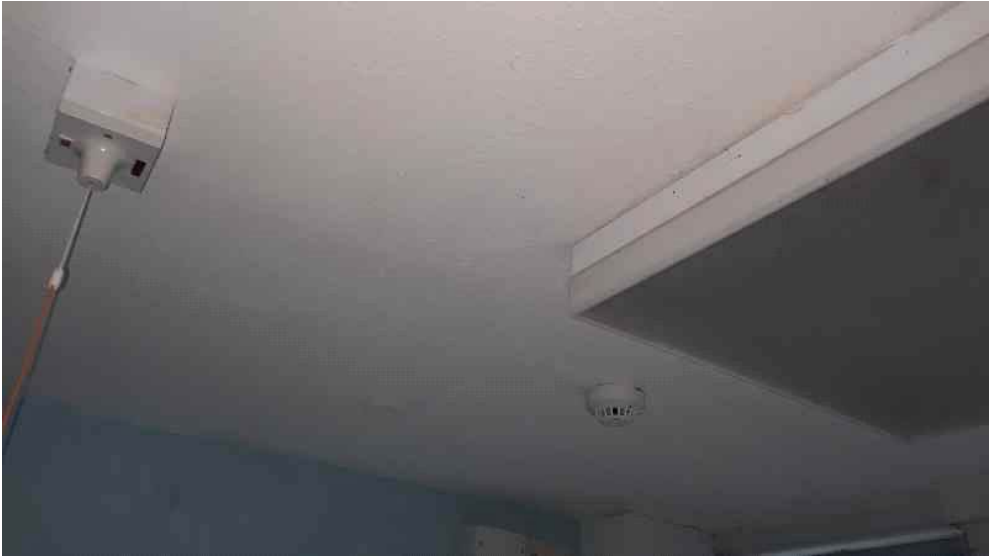
Inspection Number	88	Reference Number:	As Sample EC002601
Inspection / Sample	Visually similar to	Inspection Cross Reference / Visual I.D.	As Sample

Building	Main Building
Floor Level	1st Floor
Area / Room	1.21 Disabled W.C
Feature	Textured coating to plasterboard ceiling
Product Type	Textured Coating
Extent Amount	6 m ²

Product Score	Low Fibre Release - Asbestos reinforced composites (plastics, resins, mastics, roofing felts, vinyl floor tiles, semi-rigid paints or decorative finishes, asbestos cement, etc.)	1
Extent of Damage	Good condition - no visible damage	0
Surface Treatment	Enclosed sprays and lagging, Sealed AIB, asbestos cement, textured coating, gasket	1
Asbestos Type	Chrysotile	1

Recommendation	Manage
----------------	--------

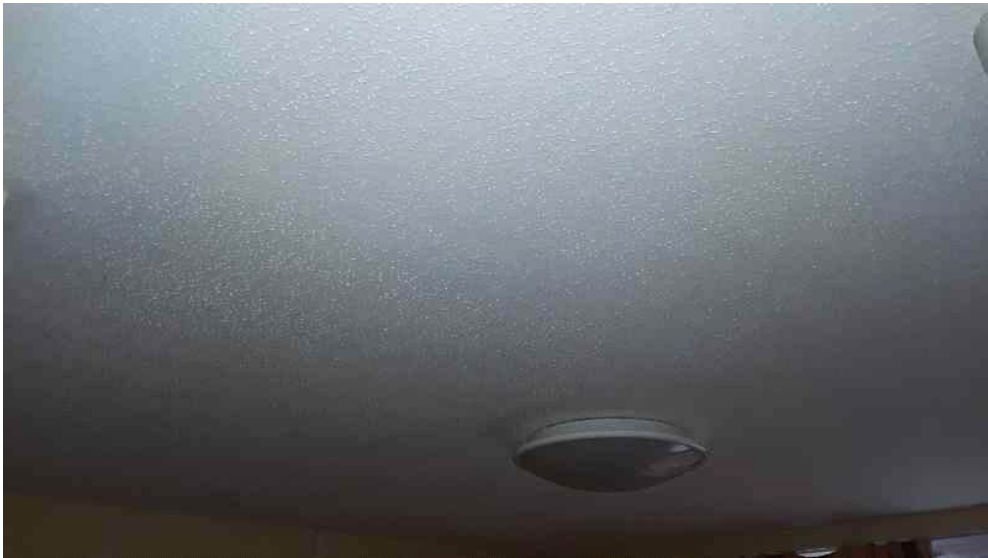
Inspection Number	89	Reference Number:	EC002603
Inspection / Sample	Sample taken	Inspection Cross Reference / Visual I.D.	N.A.D.I.S

Building	Main Building
Floor Level	1st Floor
Area / Room	1.22 Bedroom 19
Feature	Textured coating to plasterboard ceiling
Product Type	Textured Coating
Extent Amount	8 m2

Product Score	Low Fibre Release - Asbestos reinforced composites (plastics, resins, mastics, roofing felts, vinyl floor tiles, semi-rigid paints or decorative finishes, asbestos cement, etc.)	0
Extent of Damage	Good condition - no visible damage	0
Surface Treatment	Enclosed sprays and lagging, Sealed AIB, asbestos cement, textured coating, gasket	0
Asbestos Type	No Asbestos Detected	0

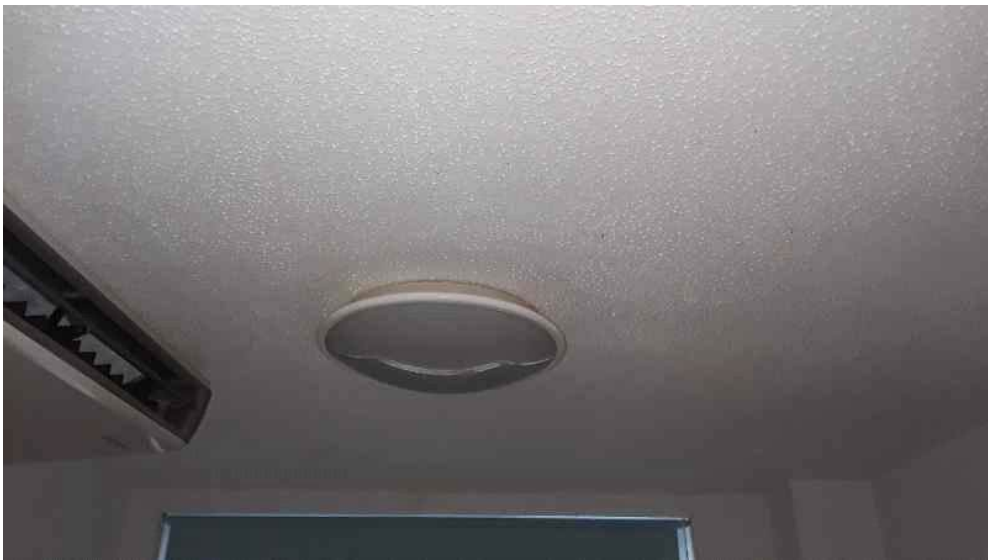
Inspection Number	90	Reference Number:	As Sample EC002601
Inspection / Sample	Visually similar to	Inspection Cross Reference / Visual I.D.	As Sample

Building	Main Building
Floor Level	1st Floor
Area / Room	1.23 Dining Room
Feature	Textured coating to plasterboard ceiling
Product Type	Textured Coating
Extent Amount	6 m ²

Product Score	Low Fibre Release - Asbestos reinforced composites (plastics, resins, mastics, roofing felts, vinyl floor tiles, semi-rigid paints or decorative finishes, asbestos cement, etc.)	1
Extent of Damage	Good condition - no visible damage	0
Surface Treatment	Enclosed sprays and lagging, Sealed AIB, asbestos cement, textured coating, gasket	1
Asbestos Type	Chrysotile	1

Recommendation	Manage
----------------	--------

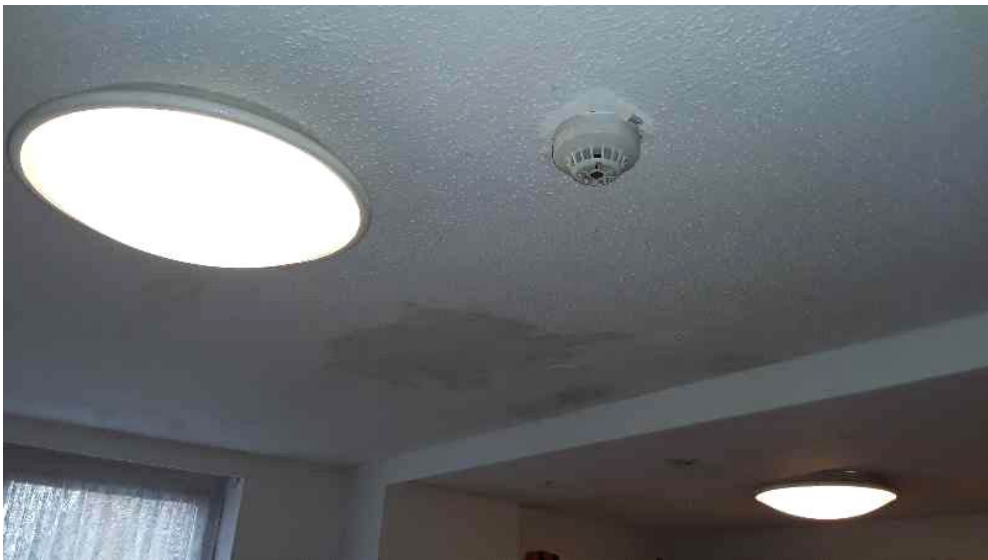
Inspection Number	91	Reference Number:	As Sample EC002601
Inspection / Sample	Visually similar to	Inspection Cross Reference / Visual I.D.	As Sample

Building	Main Building
Floor Level	1st Floor
Area / Room	1.24 Kitchen
Feature	Textured coating to plasterboard ceiling
Product Type	Textured Coating
Extent Amount	12 m ²

Product Score	Low Fibre Release - Asbestos reinforced composites (plastics, resins, mastics, roofing felts, vinyl floor tiles, semi-rigid paints or decorative finishes, asbestos cement, etc.)	1
Extent of Damage	Low damage - a few scratches or surface marks; broken edges on boards, tiles etc.	1
Surface Treatment	Enclosed sprays and lagging, Sealed AIB, asbestos cement, textured coating, gasket	1
Asbestos Type	Chrysotile	1

Recommendation	Manage
----------------	--------

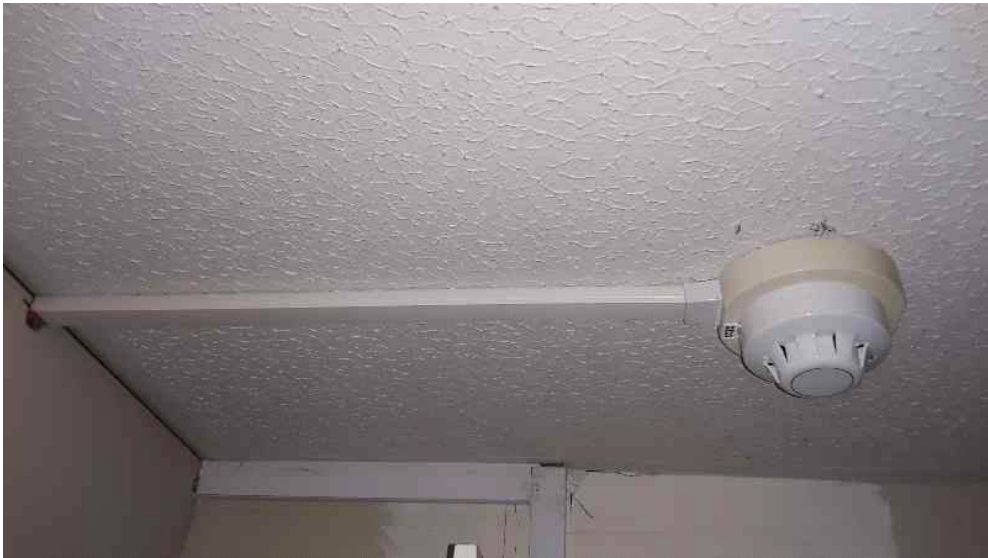
Inspection Number	92	Reference Number:	As Sample EC002601
Inspection / Sample	Visually similar to	Inspection Cross Reference / Visual I.D.	As Sample

Building	Main Building
Floor Level	1st Floor
Area / Room	1.25 Store
Feature	Textured coating to plasterboard ceiling
Product Type	Textured Coating
Extent Amount	1 m ²

Product Score	Low Fibre Release - Asbestos reinforced composites (plastics, resins, mastics, roofing felts, vinyl floor tiles, semi-rigid paints or decorative finishes, asbestos cement, etc.)	1
Extent of Damage	Good condition - no visible damage	0
Surface Treatment	Enclosed sprays and lagging, Sealed AIB, asbestos cement, textured coating, gasket	1
Asbestos Type	Chrysotile	1

Recommendation	Manage
----------------	--------

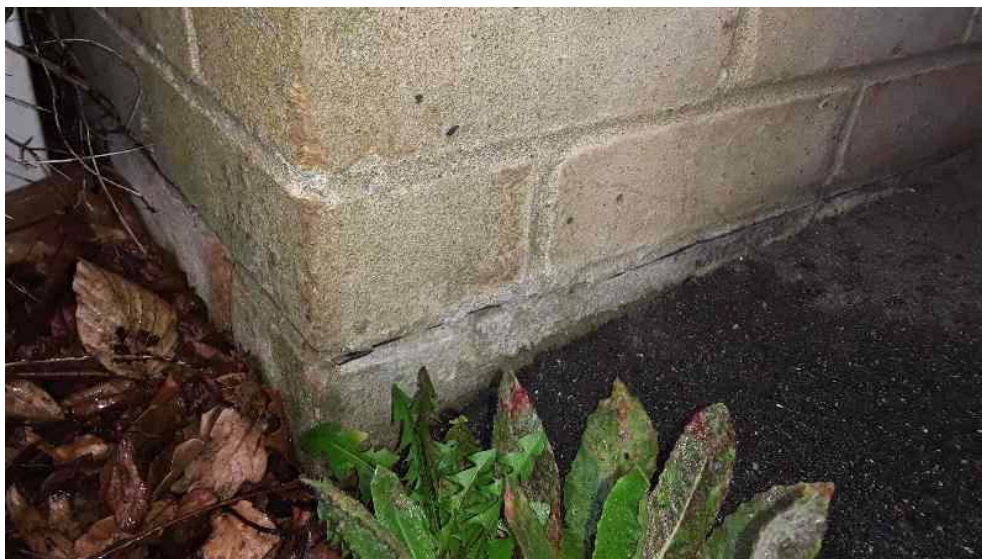
Inspection Number	93	Reference Number:	EC002604
Inspection / Sample	Sample taken	Inspection Cross Reference / Visual I.D.	N.A.D.I.S

Building	Main Building
Floor Level	External
Area / Room	0.E01 External
Feature	Bitumen damp proof course to base of brickwork
Product Type	Well Bound Material
Extent Amount	200 lm

Product Score	Low Fibre Release - Asbestos reinforced composites (plastics, resins, mastics, roofing felts, vinyl floor tiles, semi-rigid paints or decorative finishes, asbestos cement, etc.)	0
Extent of Damage	Good condition - no visible damage	0
Surface Treatment	Reinforced plastics, resins, vinyl tiles, well bound materials, bitumen adhesives, damp proof course	0
Asbestos Type	No Asbestos Detected	0

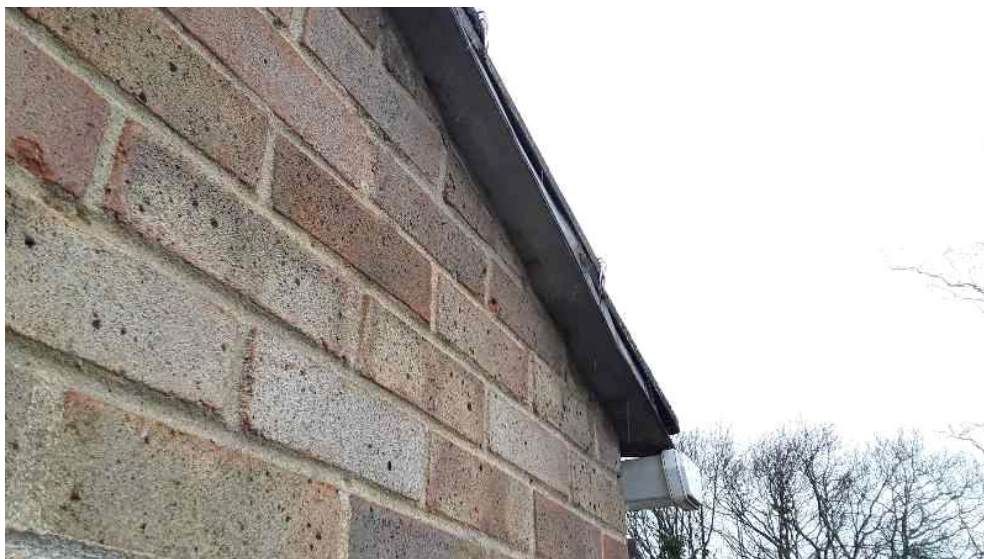
Inspection Number	94	Reference Number:	EC002606
Inspection / Sample	Sample taken	Inspection Cross Reference / Visual I.D.	N.A.D.I.S

Building	Main Building
Floor Level	External
Area / Room	0.R01 Roof
Feature	Cement undercloak to pitched roof
Product Type	Cement
Extent Amount	60 lm

Product Score	Low Fibre Release - Asbestos reinforced composites (plastics, resins, mastics, roofing felts, vinyl floor tiles, semi-rigid paints or decorative finishes, asbestos cement, etc.)	0
Extent of Damage	Good condition - no visible damage	0
Surface Treatment	Enclosed sprays and lagging, Sealed AIB, asbestos cement, textured coating, gasket	0
Asbestos Type	No Asbestos Detected	0

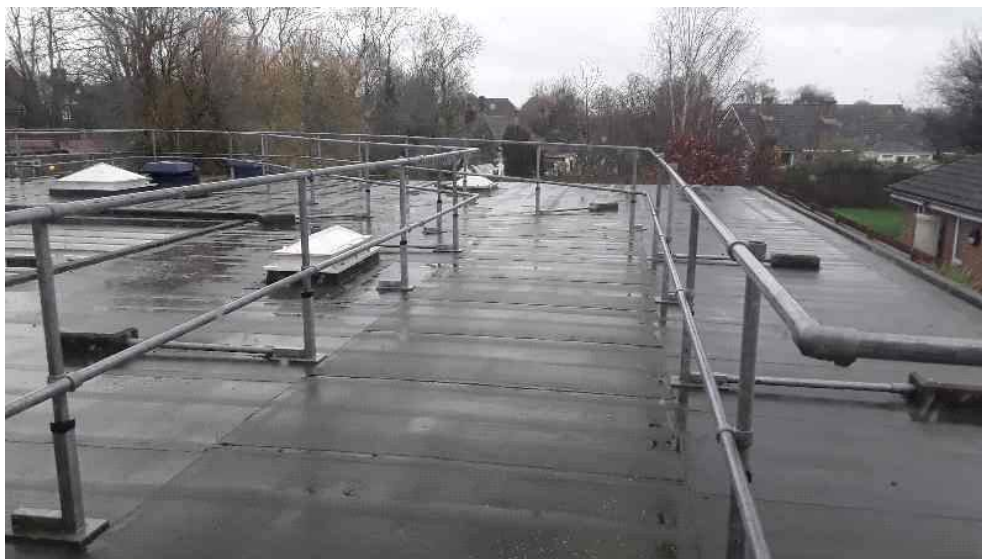
Inspection Number	95	Reference Number:	EC002605
Inspection / Sample	Sample taken	Inspection Cross Reference / Visual I.D.	N.A.D.I.S

Building	Main Building
Floor Level	External
Area / Room	0.R01 Roof
Feature	Felt lining to flat roofs
Product Type	Well Bound Material
Extent Amount	250 m ²

Product Score	Low Fibre Release - Asbestos reinforced composites (plastics, resins, mastics, roofing felts, vinyl floor tiles, semi-rigid paints or decorative finishes, asbestos cement, etc.)	0
Extent of Damage	Good condition - no visible damage	0
Surface Treatment	Reinforced plastics, resins, vinyl tiles, well bound materials, bitumen adhesives, damp proof course	0
Asbestos Type	No Asbestos Detected	0

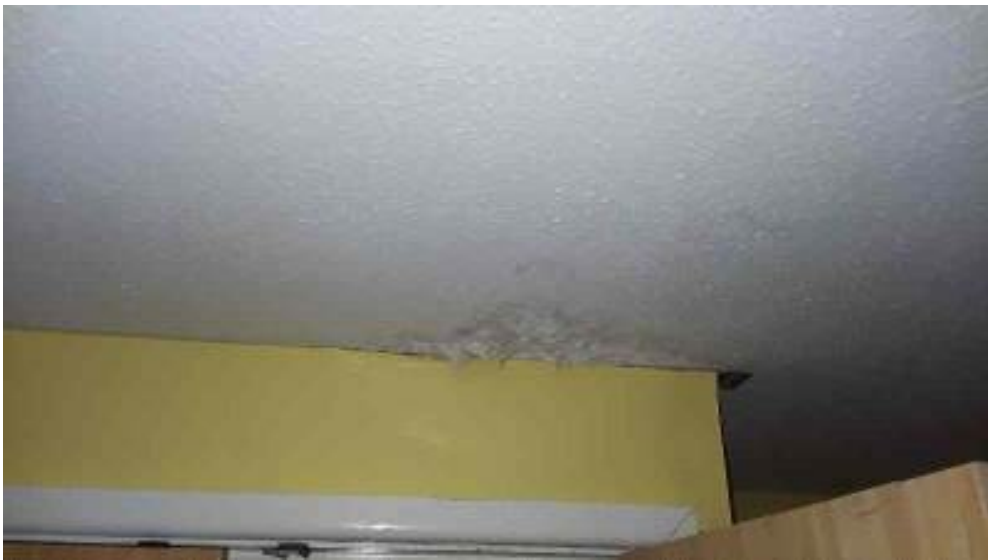
Inspection Number	97	Reference Number:	As Sample EC002601
Inspection / Sample	Visually similar to	Inspection Cross Reference / Visual I.D.	As Sample

Building	Main Building
Floor Level	1st Floor
Area / Room	1.18 Bedroom 16
Feature	Textured coating to plasterboard ceiling
Product Type	Textured Coating
Extent Amount	15 m ²

Product Score	Low Fibre Release - Asbestos reinforced composites (plastics, resins, mastics, roofing felts, vinyl floor tiles, semi-rigid paints or decorative finishes, asbestos cement, etc.)	1
Extent of Damage	Good condition - no visible damage	0
Surface Treatment	Reinforced plastics, resins, vinyl tiles, well bound materials, bitumen adhesives, damp proof course	0
Asbestos Type	Chrysotile	1

Recommendation	Manage
----------------	--------

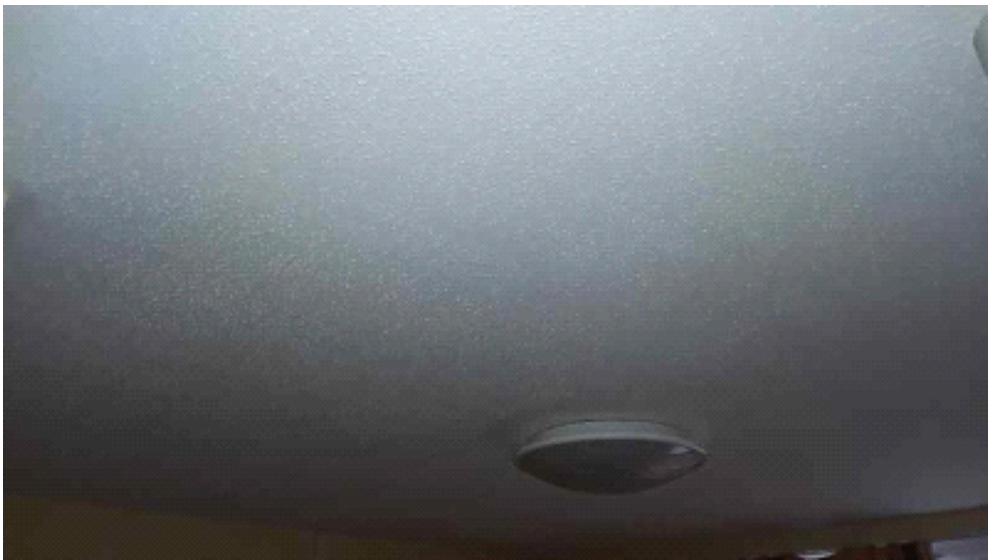
Inspection Number	98	Reference Number:	As Sample EC002601
Inspection / Sample	Visually similar to	Inspection Cross Reference / Visual I.D.	As Sample

Building	Main Building
Floor Level	1st Floor
Area / Room	1.22 Bedroom 19
Feature	Textured coating to plasterboard ceiling
Product Type	Textured Coating
Extent Amount	8 m ²

Product Score	Low Fibre Release - Asbestos reinforced composites (plastics, resins, mastics, roofing felts, vinyl floor tiles, semi-rigid paints or decorative finishes, asbestos cement, etc.)	1
Extent of Damage	Good condition - no visible damage	0
Surface Treatment	Enclosed sprays and lagging, Sealed AIB, asbestos cement, textured coating, gasket	1
Asbestos Type	Chrysotile	1

Recommendation	Manage
----------------	--------

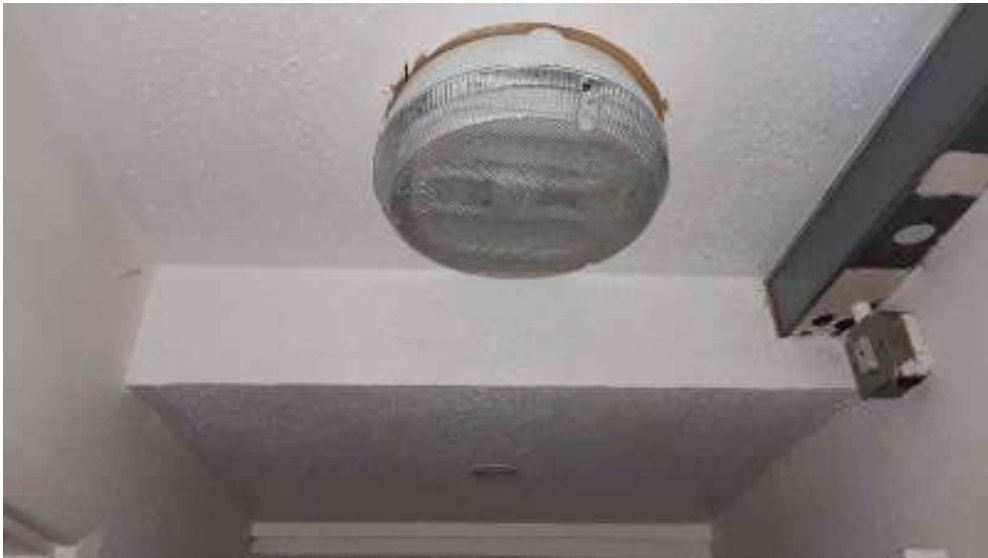
Inspection Number	99	Reference Number:	As Sample EC002540
Inspection / Sample	Visually similar to	Inspection Cross Reference / Visual I.D.	As Sample

Building	Main Building
Floor Level	Ground Floor
Area / Room	0.C01 Circulation
Feature	textured coating to plasterboard ceiling
Product Type	Textured Coating
Extent Amount	2 m ²

Product Score	Low Fibre Release - Asbestos reinforced composites (plastics, resins, mastics, roofing felts, vinyl floor tiles, semi-rigid paints or decorative finishes, asbestos cement, etc.)	1
Extent of Damage	Good condition - no visible damage	0
Surface Treatment	Enclosed sprays and lagging, Sealed AIB, asbestos cement, textured coating, gasket	1
Asbestos Type	Chrysotile	1

Recommendation	Manage
----------------	--------

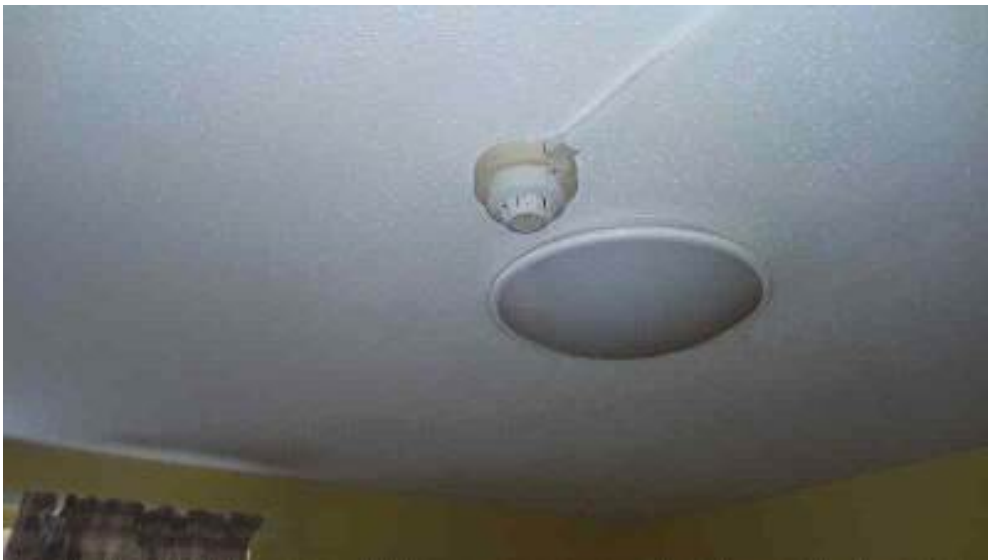
Inspection Number	100	Reference Number:	As Sample EC002540
Inspection / Sample	Visually similar to	Inspection Cross Reference / Visual I.D.	As Sample

Building	Main Building
Floor Level	Ground Floor
Area / Room	0.14 Bedroom 9
Feature	Textured coating to plasterboard ceiling
Product Type	Textured Coating
Extent Amount	9 m2

Product Score	Low Fibre Release - Asbestos reinforced composites (plastics, resins, mastics, roofing felts, vinyl floor tiles, semi-rigid paints or decorative finishes, asbestos cement, etc.)	1
Extent of Damage	Good condition - no visible damage	0
Surface Treatment	Enclosed sprays and lagging, Sealed AIB, asbestos cement, textured coating, gasket	1
Asbestos Type	Chrysotile	1

Recommendation	Manage
----------------	--------

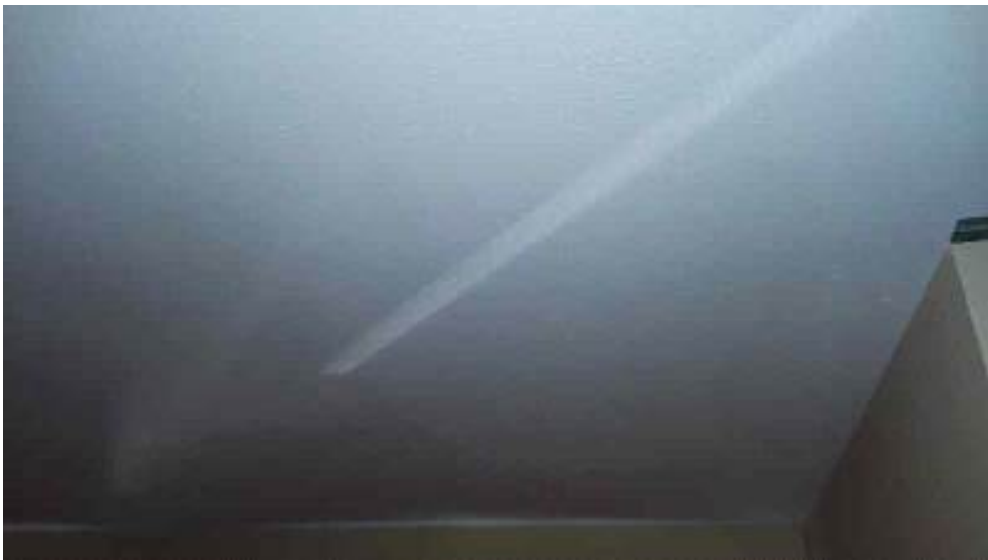
Inspection Number	101	Reference Number:	As Sample EC002540
Inspection / Sample	Visually similar to	Inspection Cross Reference / Visual I.D.	As Sample

Building	Main Building
Floor Level	Ground Floor
Area / Room	0.22 Bedroom 8
Feature	Textured coating to plasterboard ceiling
Product Type	Textured Coating
Extent Amount	12 m ²

Product Score	Low Fibre Release - Asbestos reinforced composites (plastics, resins, mastics, roofing felts, vinyl floor tiles, semi-rigid paints or decorative finishes, asbestos cement, etc.)	1
Extent of Damage	Good condition - no visible damage	0
Surface Treatment	Enclosed sprays and lagging, Sealed AIB, asbestos cement, textured coating, gasket	1
Asbestos Type	Chrysotile	1

Recommendation	Manage
----------------	--------
