ARBORICULTURAL IMPACT ASSESSMENT

KENT COUNTY COUNCIL
WALDESLADE ROUND WOOD SITE
WALDESLADE WOODS
WALDESLADE,
BOXLEY,
KENT

REF NO. 3478_RP_004-A

LLOYD BORE LTD
33 ST GEORGES PLACE
CANTERBURY
KENT CT1 1UT

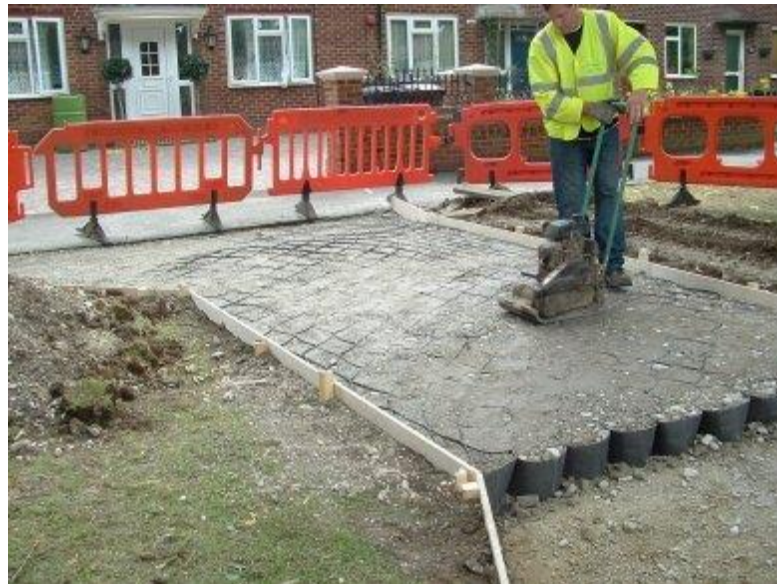
Fig 1. Cellular confinement system

- 12.7. For wheeled or tracked construction traffic movements within the CEZ, the ground protection should be designed by an engineer to accommodate the likely loading and may involve the use of proprietary systems of metal, polymer or wooden panels or reinforced concrete slabs, examples of which follow. Cellular confinement no-dig systems can also be used.
